HEAVY VEHICLES TIRE BLOWOUT AND EXPLOSION

March 2009

This technical fact sheet is a summary of the research report* produced by:

- * Exploratory study of heavy truck tire blowout and explosion phenomena.
- * The document can be consulted or downloaded free of charge at: http://www.irsst.qc.ca/files/documents/ PubIRSST/R-479.pdf.

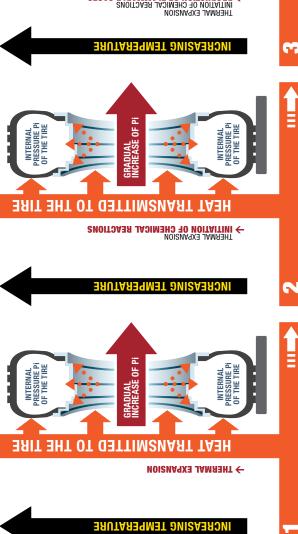
Heating of the air in the tire, which expands and causes an increase in pressure: risk of tire blowout.

When heated to around 185°C (this temperature may correspond to air temperatures in the tire as low as 100°C), the rubber begins to degrade, producing flammable gases and materials, further increasing the pressure in the tire: risk of tire blowout.

> If the heat buildup continues, the accumulation of flammable gases and materials due to degradation of the rubber continues.

When the critical concentration of Mhen the critical concentration of flammable gases and materials is reached in the presence of oxygen at auto-ignition temperature and pressure : explosion occurs.

If the heat is sufficiently intense to reach step 3, and the tire does not cool down, and the heat continues to be transmitted to the tire; the time to reach step 4, where the risk of explosion is significant, can vary from a few minutes to more than one hour.

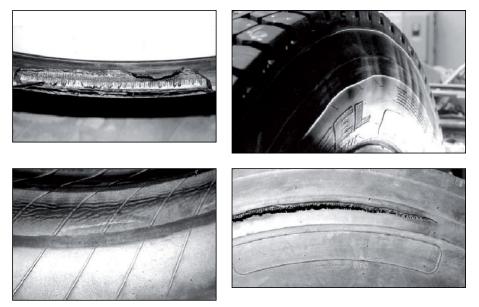
Always check for signs of fatigue on the tire in order to avoid the phenomenon of blowout associated with zipper failure.

- Examples of observable elements:
 - check for the presence of marbling (black lines around the inside circumference of the sidewalls)
 - check for the presence of signs of separation or deformation of the liner inside the tire
 - check for the presence of carbon dust originating from the destruction of the liner
 - check carefully the sidewalls of the tire to detect any distortion, cracks, small breaks, cracking, exposed steel cord, discoloration, irregular bulging or warping, soft or more flexible spot.

If in doubt, the tire must be discarded.

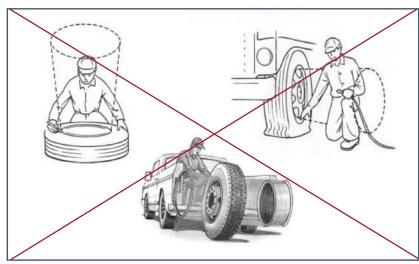
Projection danger zone during tire inflation.

On the photograph at the left, you can see the trajectory that the debris may take following tire blowout.

- Place the wheel in a safety cage
- Always use a clip-on air chuck with air hose extension equipped with a control valve and a pressure gauge
- Maintain a safe distance (approximately 2 m) between the worker and the tire to be inflated. The worker should never stand facing the wheel but instead stand to the side so as to be facing the tread (see below).

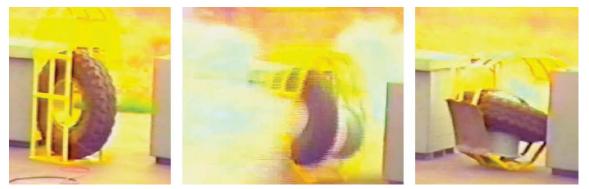
On the photographs below, we see that the energy released during blowout deforms the safety cage, as well as moving it and rotating it. It is important that the worker stay outside the trajectory of the debris and far enough away from the cage so as not to be injured by it.

Three sequences of tire blowout with projection of the rim in a safety cage.
