Evaluation of a Horizontal Lifeline System, Anchorage Connectors and Braced Trusses as Host Structure for Residential Roofing Work

STUDIES AND
RESEARCH PROJECTS

R-988

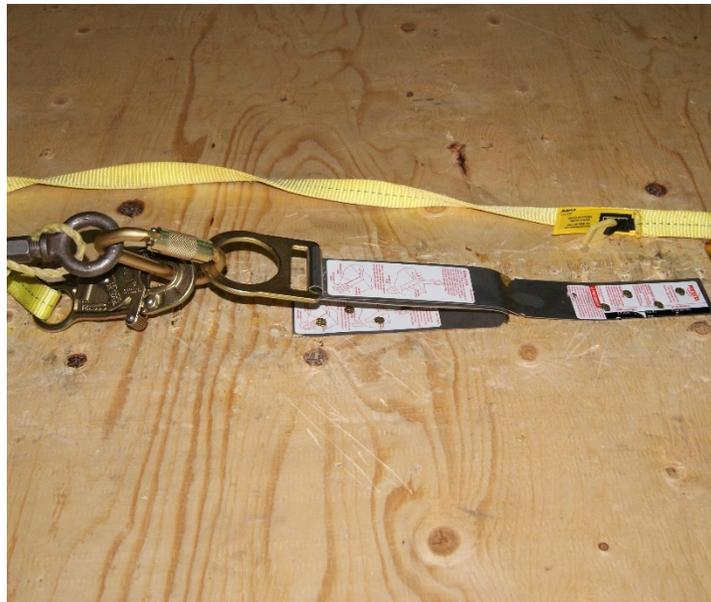
Ridge roof anchors are used as permanent anchorage connectors on wood frame structures. They consist of a zinc-plated, forged D ring on stainless steel construction, as shown in Figure 9.

Figure 9 – Ridge roof anchor

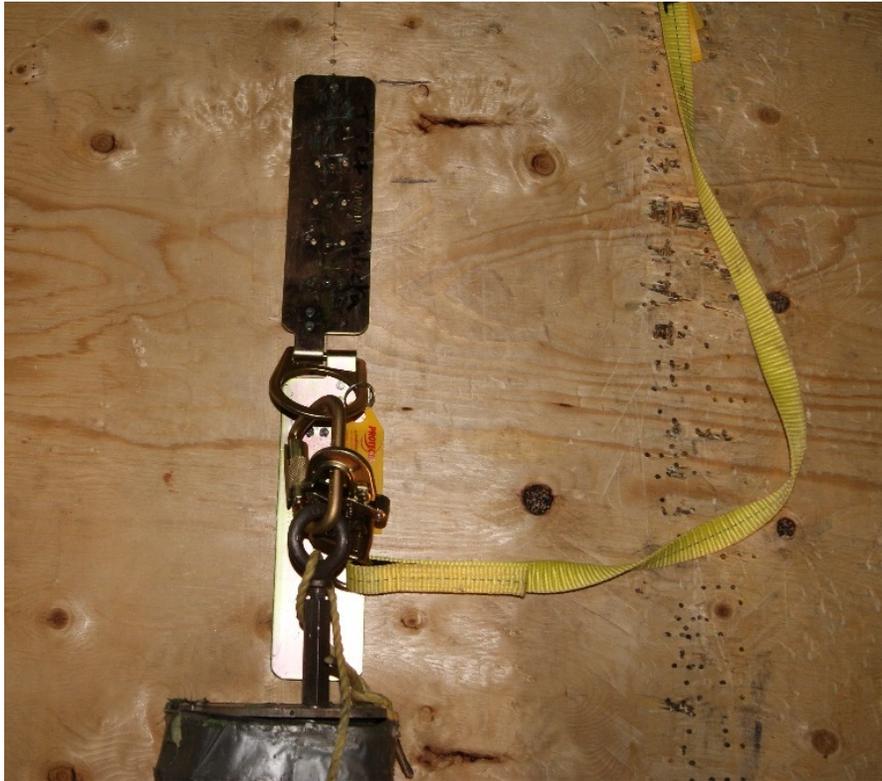
Protecta roof anchors [Figure 12] and DBI anchors are made by the same company. They are therefore identical and are installed as in the procedure described in section 2.3.2.

Figure 12 – Protecta roof anchor, model AJ730A

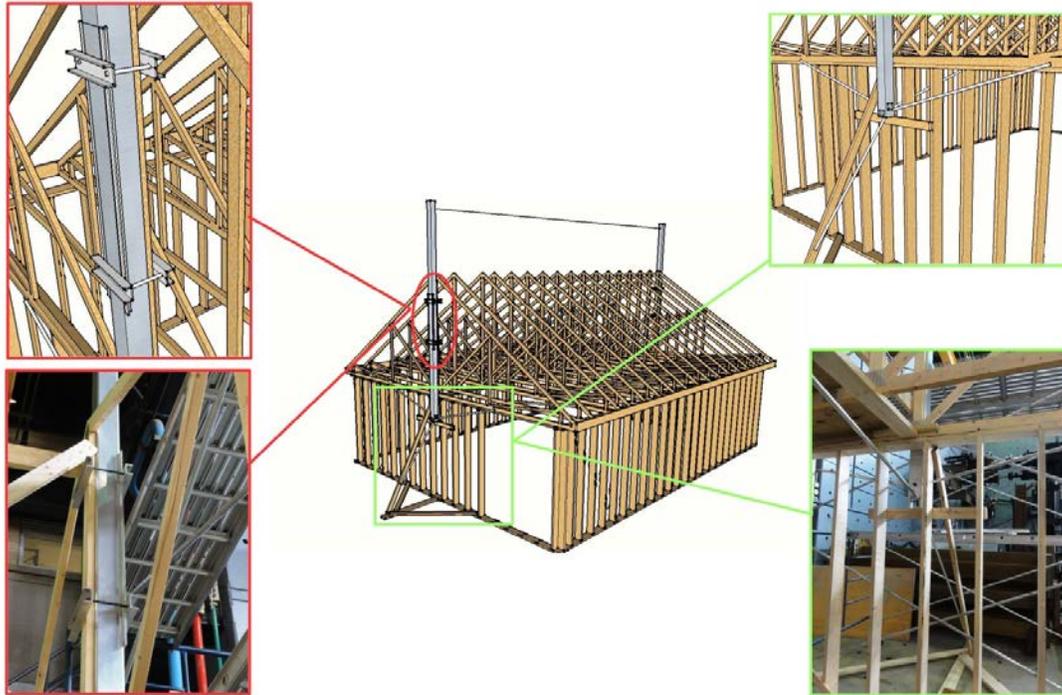
The posts of the HLLS were secured to each end of the house framework reconstructed in the lab. The details of how they were secured are shown in Figure 17. The detailed illustrations of the system for securing the post to the roof truss are bordered in red. The illustrations of the system for securing the base of the posts, consisting of four standard stabilizing rods for scaffolding, are bordered in green. Three of the rods were screwed into the host structure, while the fourth was screwed into an extension of the host structure built specifically for that purpose (Figure 18).

Figure 17 – Securing of post to host structure

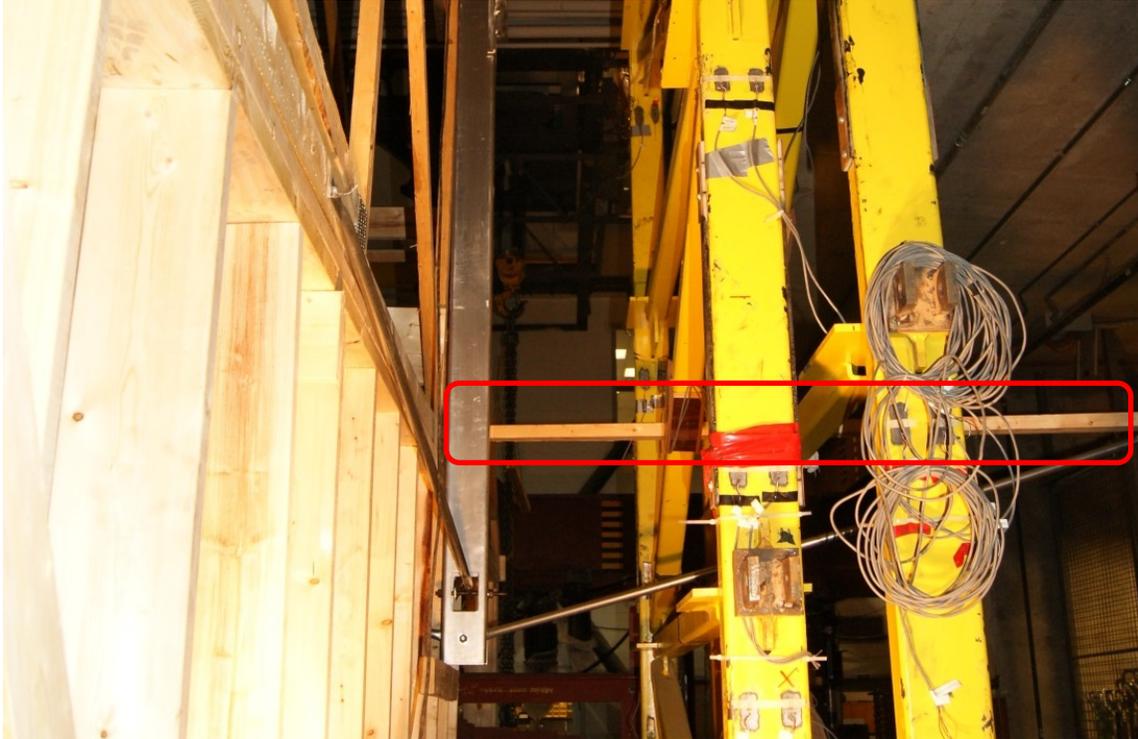
that for the west post. An anchorage located on a laboratory wall near the structure's east wall was used to place a 2 in. x 6 in. piece of lumber between it and the top of the east wall [Figure 19], to anchor the east cross brace of the east post.

Figure 19 – 2 in. x 6 in. lumber used to anchor east cross brace of east post

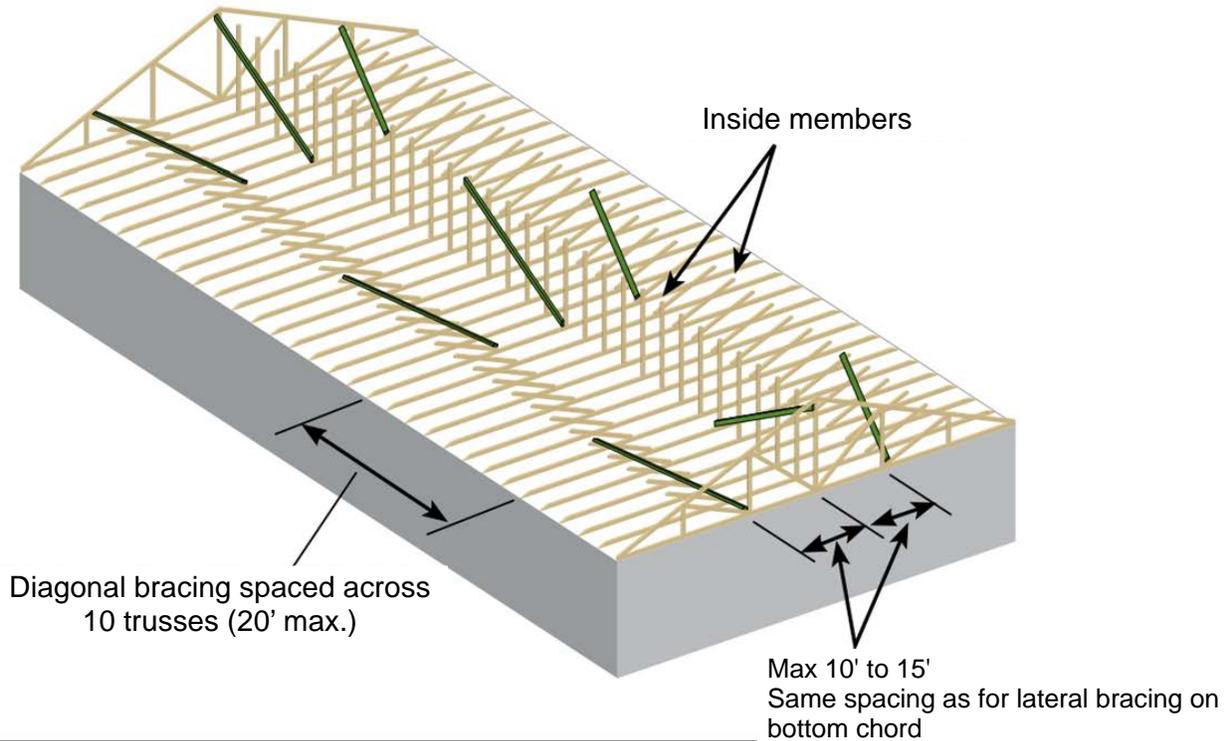
Figure 24 shows the bracing on the vertical and diagonal members of the roof trusses. This type of temporary bracing can be left in place permanently after the roof has been built and can be installed quickly because there are only a small number of parts to be nailed to the trusses.

Figure 24 – Bracing on vertical and diagonal members of roof trusses (AQFSB, 2009a, b)

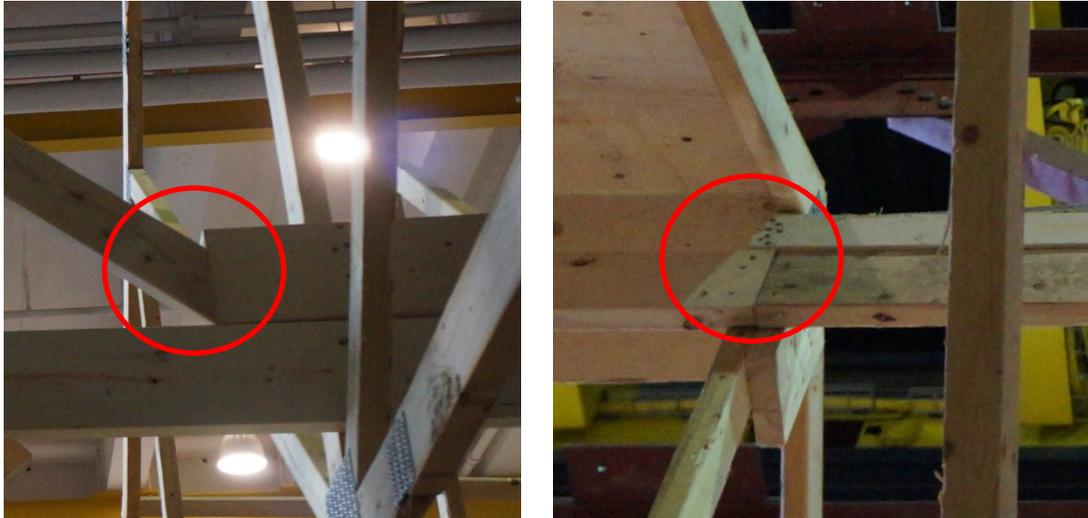
Figure 27 – Members placed end to end to enhance horizontal force transmission

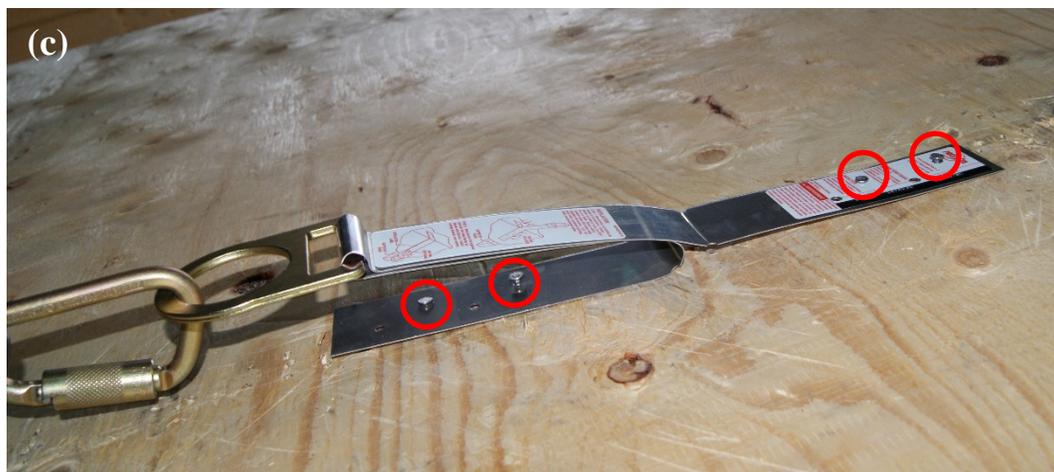
Figure 37 – Nailing of anchorage connectors for test 3 of Table 7: (a) Protecta, (b) DBI, (c) Ridge

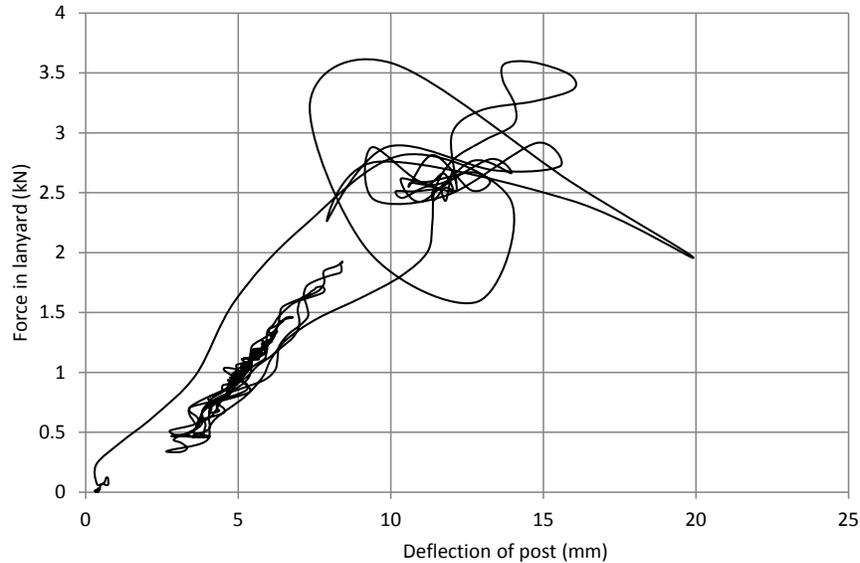
Figure 41 – Test 1: force in lanyard and deflection of post

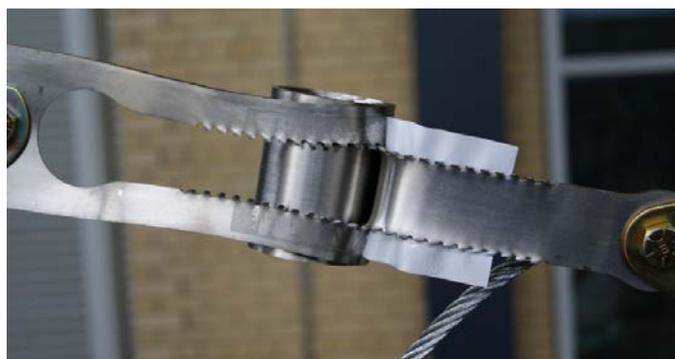
The results also indicated that the mechanism that was the most active in dissipating fall energy was the lanyard with the E4 energy absorber. Most of the harness fall indicators (five out of six) did not show ripped stitches. Figure 44, Figure 45 and Figure 46 illustrate the deployment and number of rips of the Zorbit system noted in tests 4 to 6 of Table 4.

Figure 44 – Deployment of Zorbit system with 13 rips in test 4 of Table 4

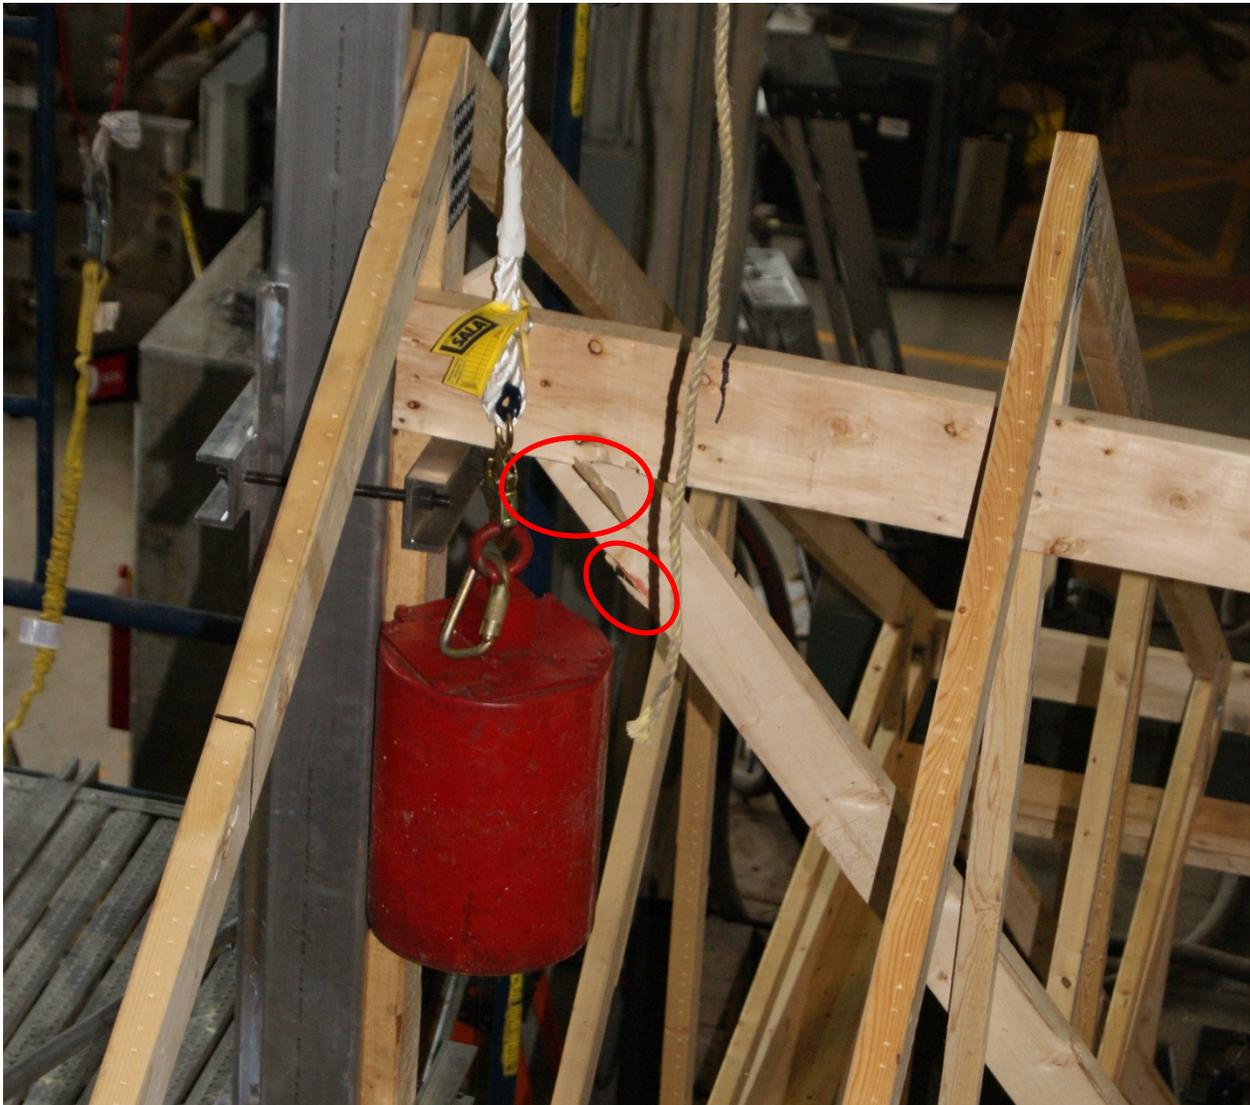
Table 10 gives the results of the tests described in Table 5. The maximum arrest forces measured in the lanyards with an energy absorber were lower than 4 kN, while they were of the order of 10 kN on average in the 5/8 in. three-strand nylon lanyards without an energy absorber. The posts, equipped with strain gauges, all remained within the elastic range. Four harness fall indicators out of six did not rip. During test 4, the bracing of the host structure gave way and the structure suffered slight damage to the roof ridge beam [Figure 50].

Figure 50 – Slight damage to host structure following test 4 of Table 5

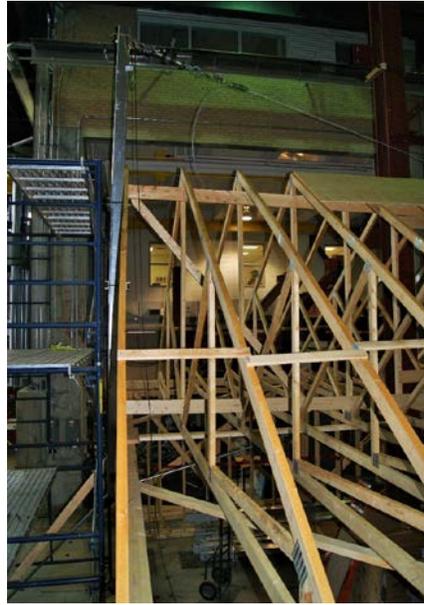
During test 1, the diagonal and the top chord of the truss bracing at the roof ridge gave way under the thrust generated by the west post [Figure 52]. As a result, the maximum anchoring forces measured during the test were small, and the total fall distance of the torso observed during the test was higher than in later tests.

Figure 52 – Rupture of diagonal and top chord on east side, during test 1 of Table 6

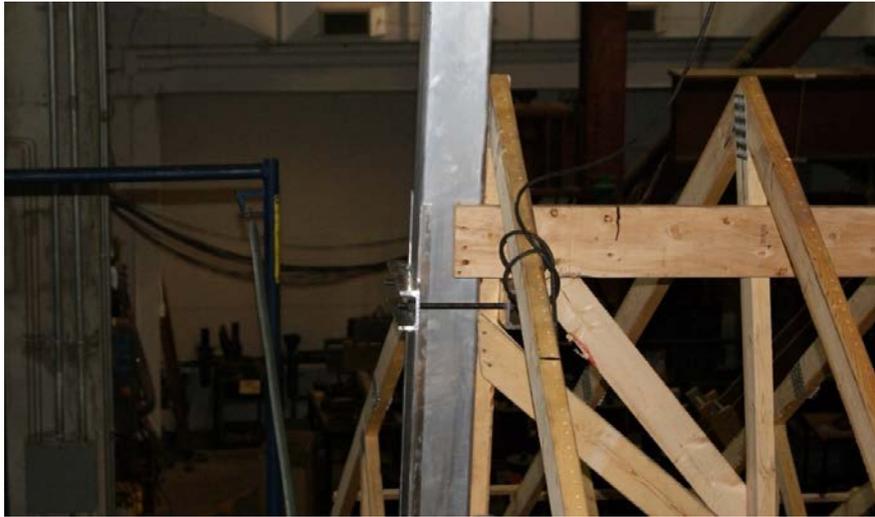
In the subsequent tests 2 to 5, no damage was observed. During test 6, however, the host structure gave way again at the roof ridge on the east side [Figure 54].

Figure 54 – Rupture at roof ridge on east side, during test 6 of Table 6

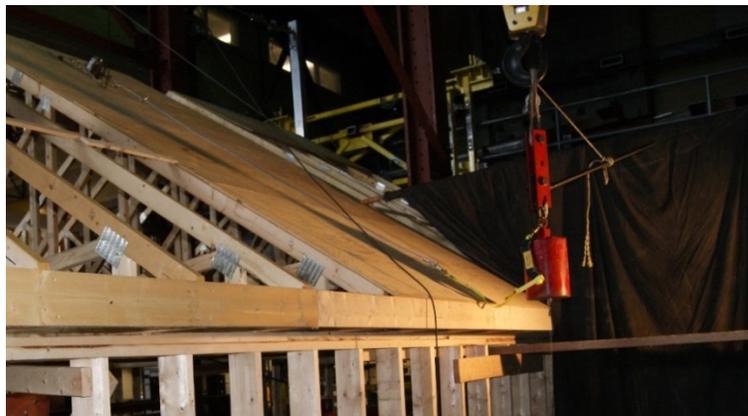
Figure 56 – Test 2: Ridge anchorage connectors

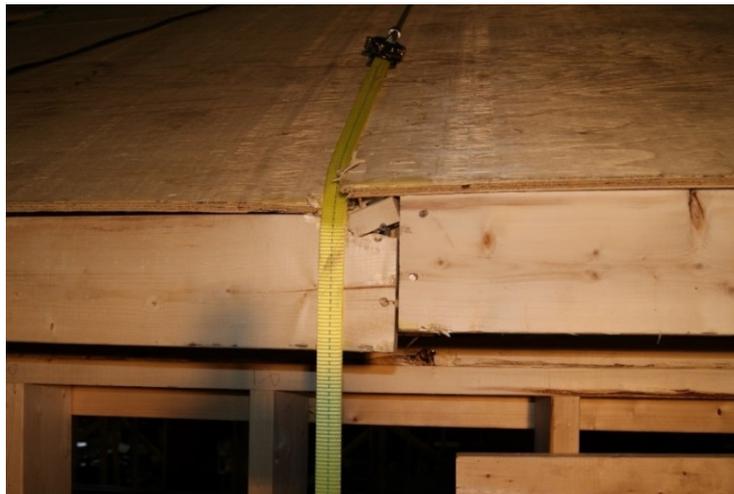
Figure 61 – Failure of roof eave in test 8 with Protecta anchor

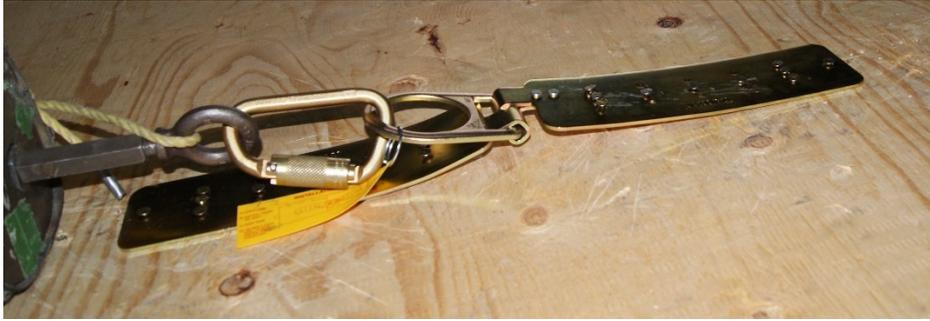
Figure 62 – Test 8 with Protecta anchorage connector: lifting and partial pulling out of nails of upper leg of anchor

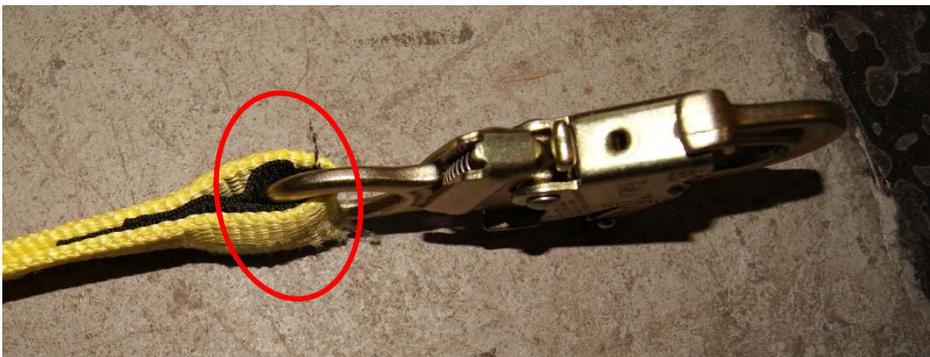
Figure 63 – Test 8 with Protecta anchorage connector: partial damage of attachment to snap hook of nylon strap lanyard

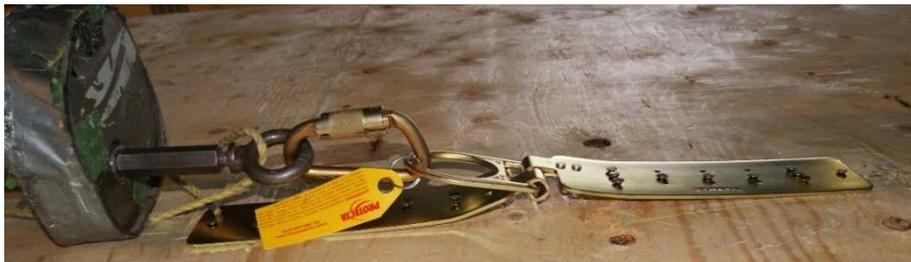
Figure 64 – Test 9 with Protecta anchorage connector: lifting and partial pulling out of nails of upper leg of anchorage connector

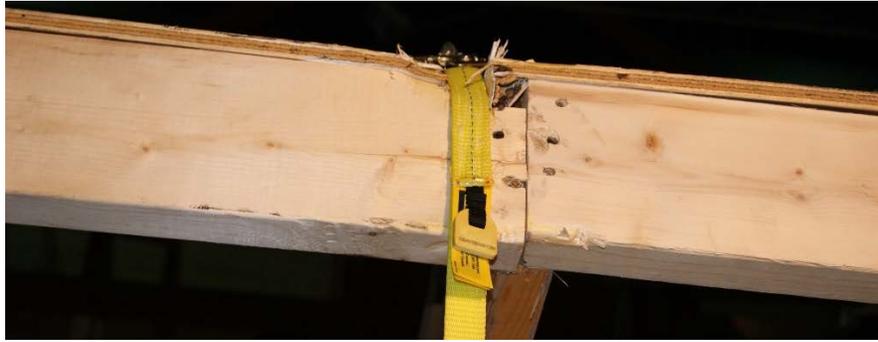
Figure 65 – Test 9 with Protecta anchorage connector: damage to roof eave

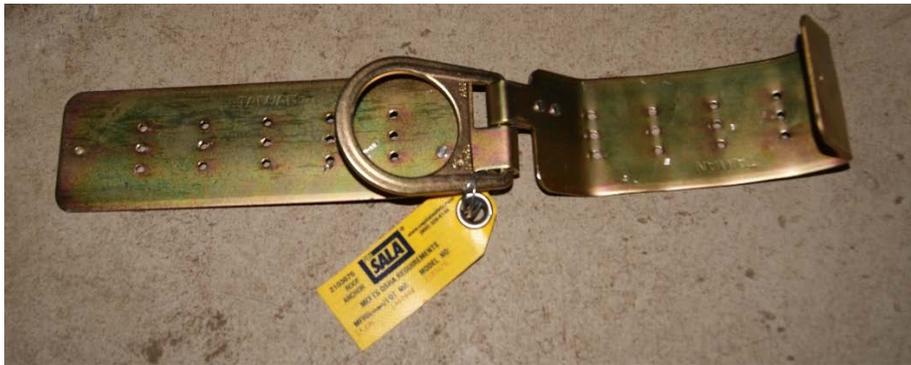
Figure 66 – Test 7 with DBI anchorage connector: state of anchor after test

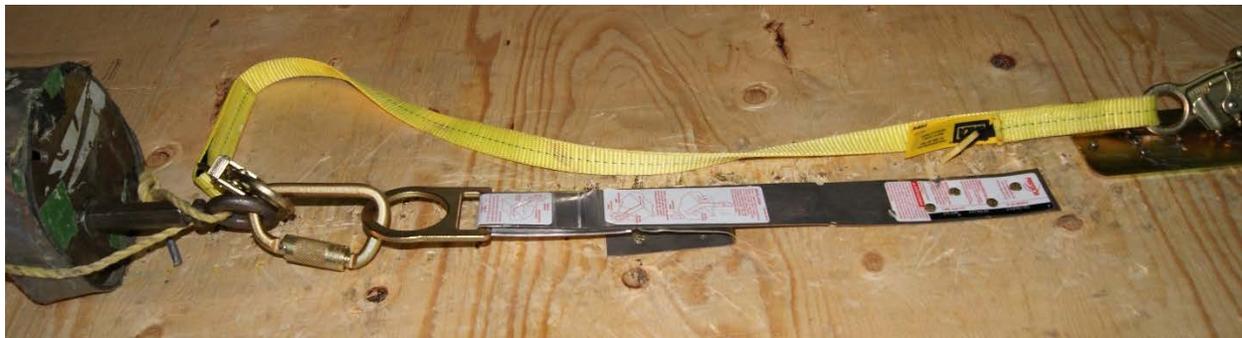
Figure 70 – Test 7 with Ridge anchorage connector: state of anchor after test

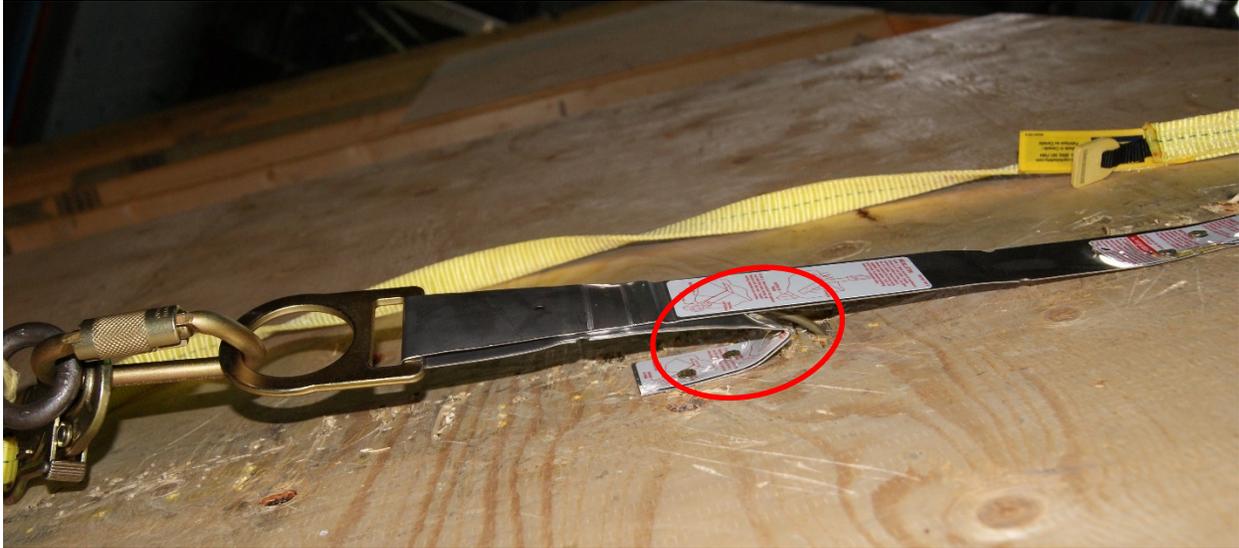
Figure 71 – Test 8 with Ridge anchorage connector: state of anchor after test

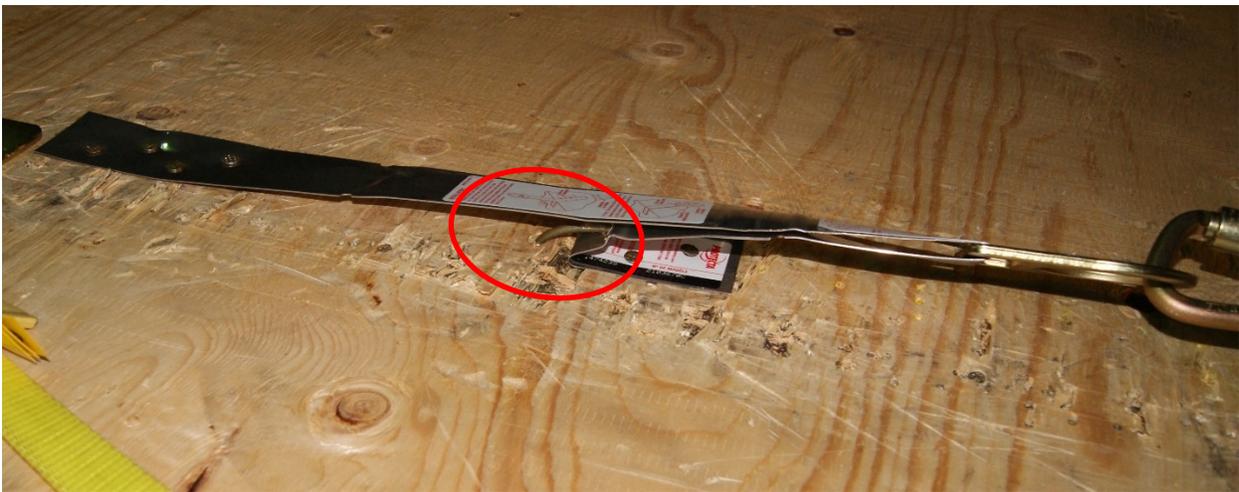
Figure 72 – Test 9 with Ridge anchorage connector: state of anchor after test
