Field test of the JNIOSH Mini Pipe Strain Meter as a safety alert system during trench work

STUDIES AND
RESEARCH PROJECTS

R-1124-en

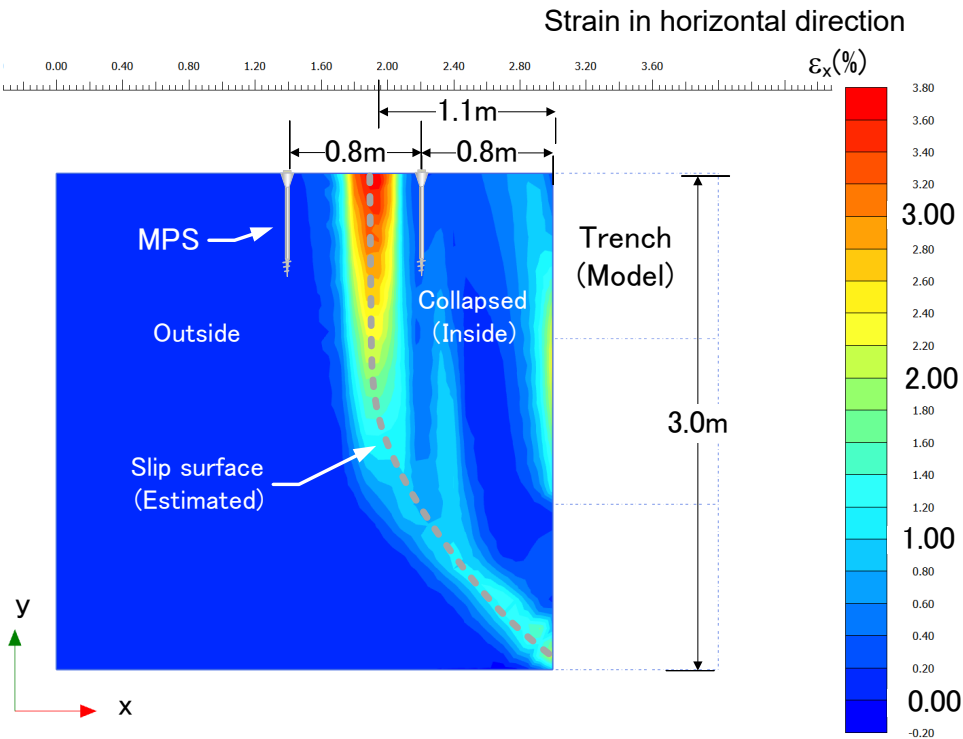
A schematic view of the distribution of a strain in the horizontal direction (ϵ_x) near the shoulder of an embankment is shown in Figure 1. In this example, using finite element model (FEM) analysis, a large increase in ϵ_x appeared near the slip surface, and its increment converged with increasing distance from the slip surface. However, it seems that a small strain in the shallow subsurface was also mobilized, corresponding to the development of the slip surface.

Figure 1. Distribution of strain in the horizontal direction, as computed from the finite element model analysis.

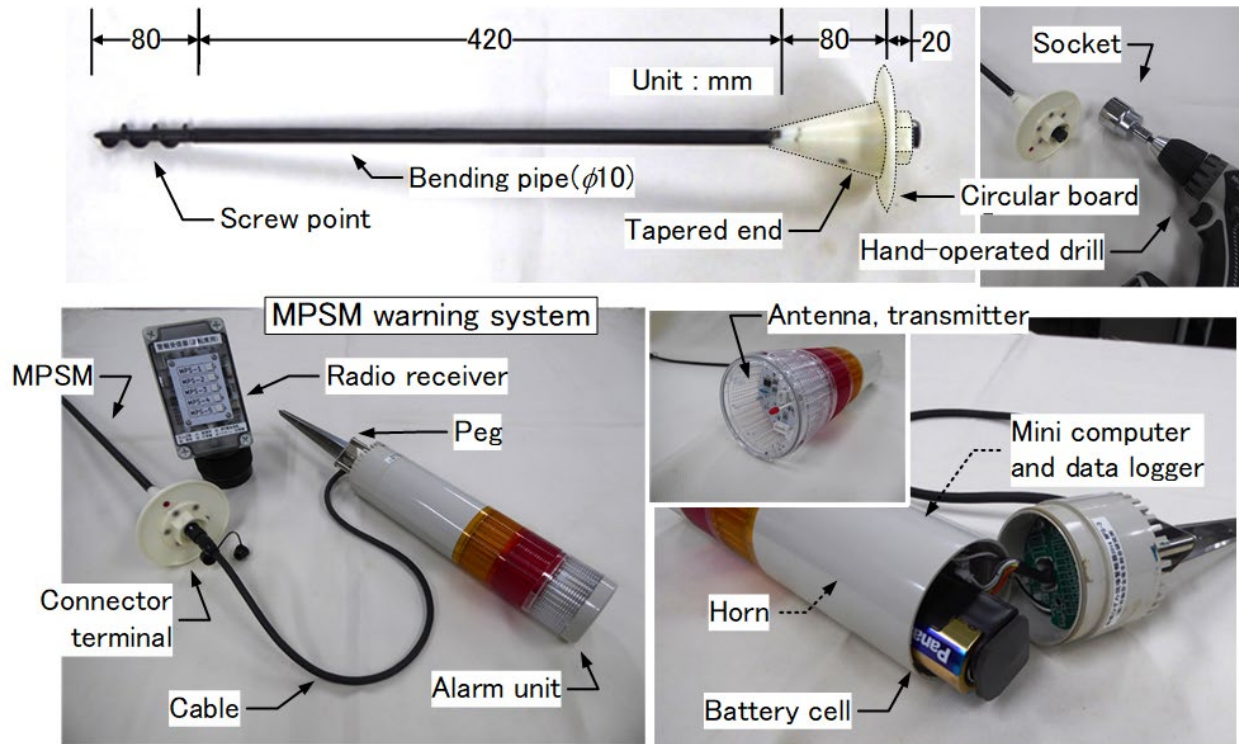
pre-boring. A 100 mm long tapered end is used to provide lateral compression to the surrounding soil so that the MPSM responds to slope movement by flexural deformation. The MPSM can be installed quickly by means of a battery-powered hand drill (Figure 3) or a manual ratchet key. The MPSM alarm system emits a sound signal to warn workers that a cave-in is imminent. One D battery cell provides the MPSM with 20-day autonomy (Figure 2).

Figure 2. Mini Pipe Strain Meter (MPSM) system.

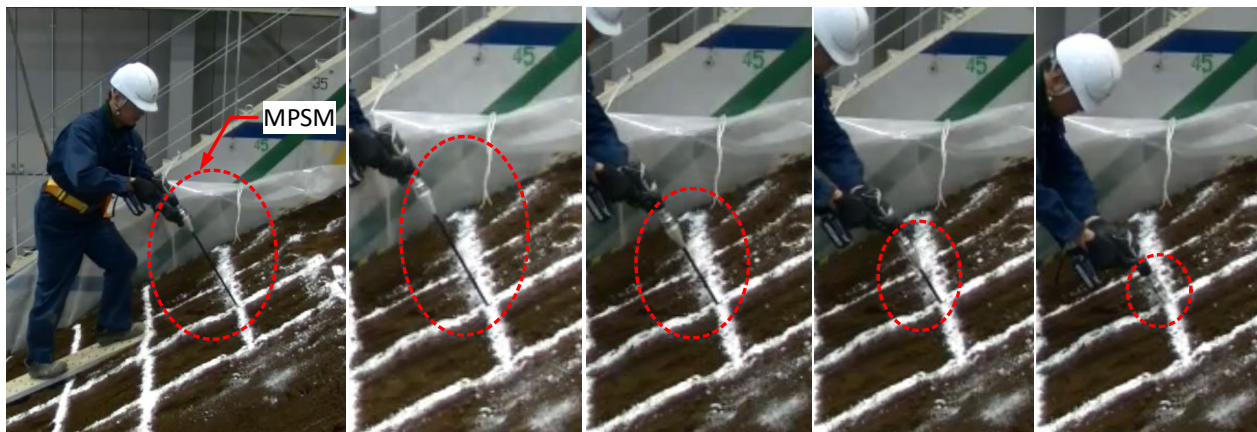
Figure 3. Installation of the MPSM by use of a hand-operated drill in less than 10 seconds.

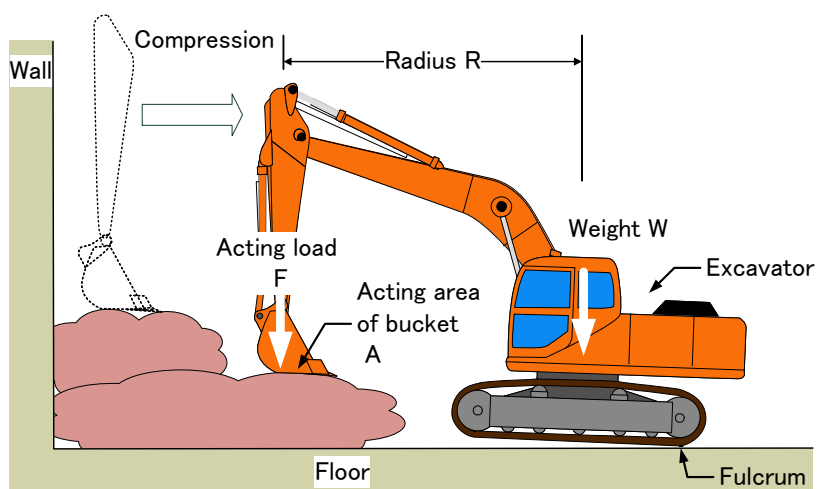
For the preparation of the slope model, a 0.3 m layer of Kanto loam was spread over a testing surface in the laboratory (Figure 4). Static compressions were then carried out using an excavator. A slope-finishing bucket was used to apply uniform pressure on the deposited soil. A radius (R) between the bucket and the center of rotation of the upper structure of the excavator was kept at about 3.5 m so that a constant value of an acting load (F) was applied through the acting area of the bucket (A).

Figure 4. Static compression of the soil material using an excavator for the preparation of the slope model.

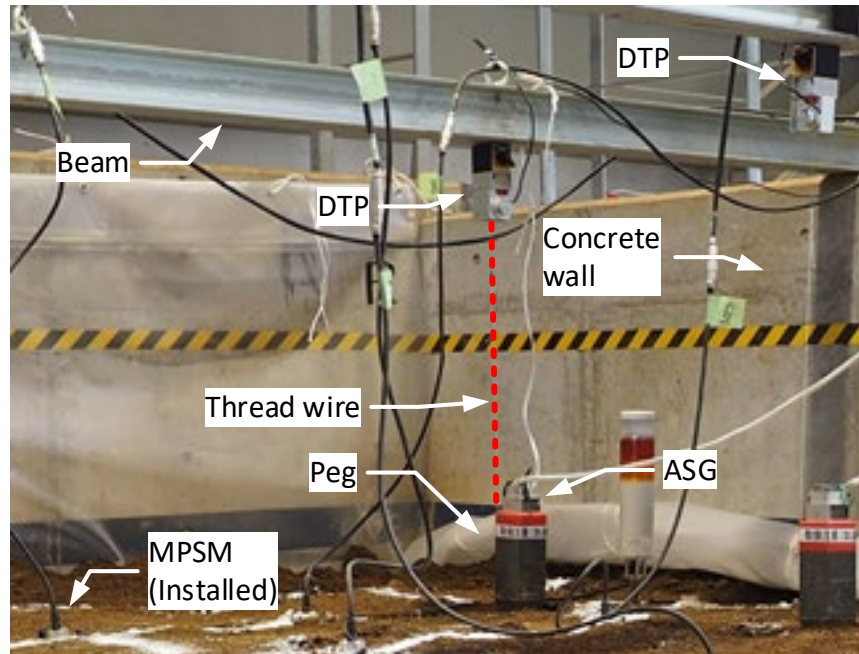
Figure 6. Installation of DTPs to measure surface settlement near the shoulder.

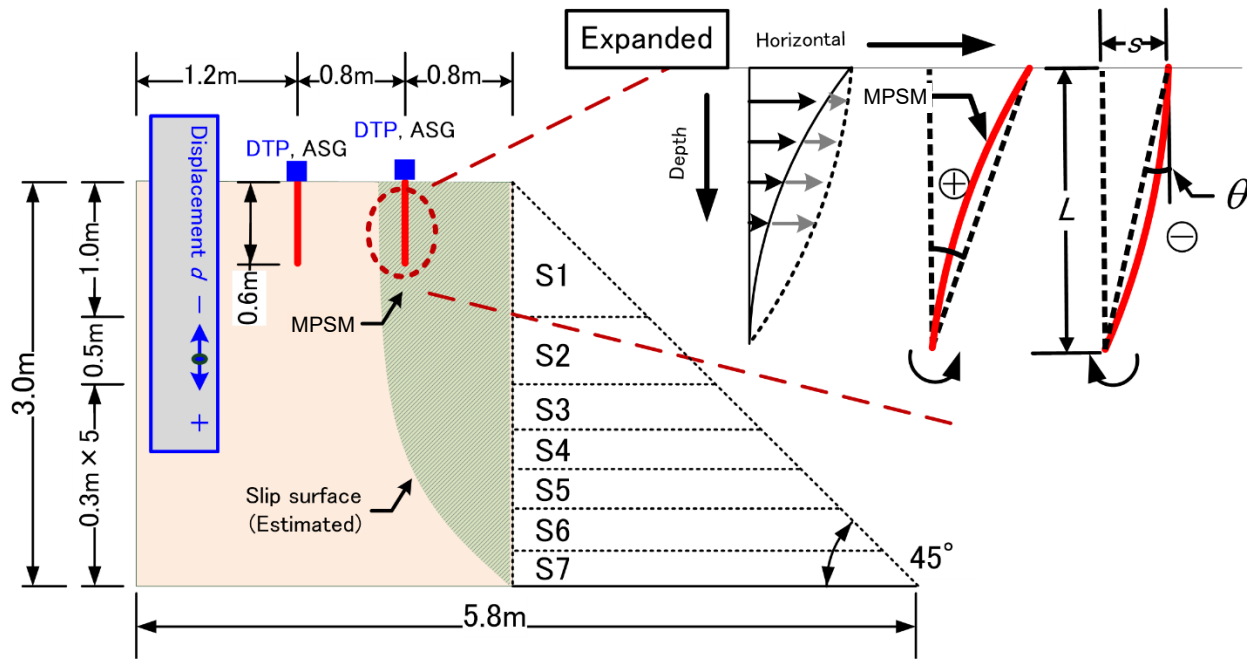
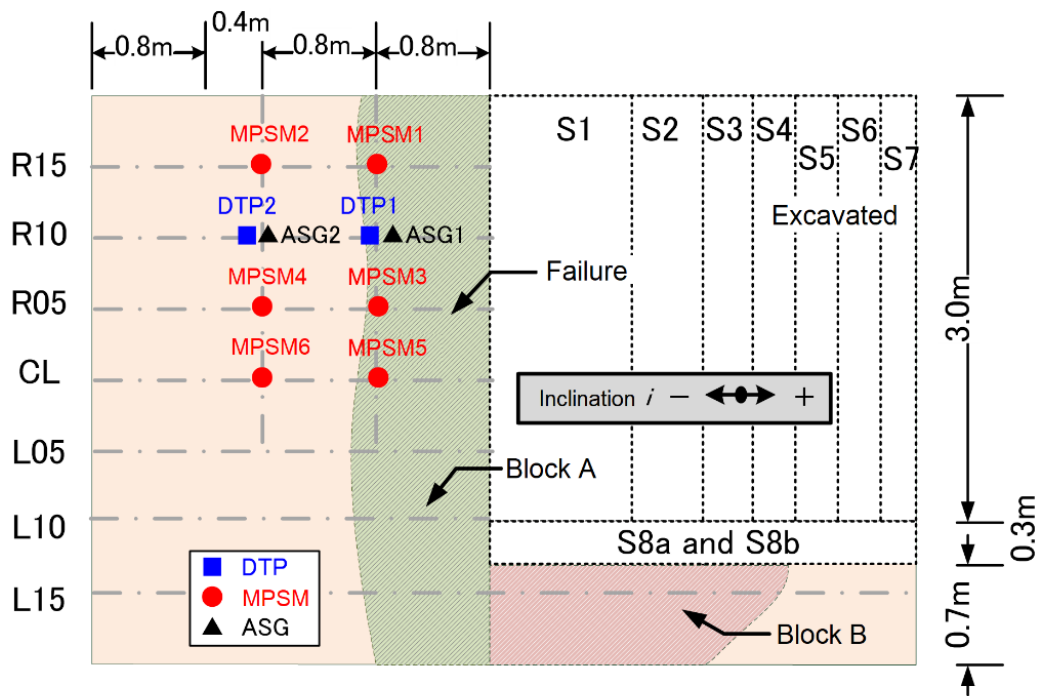
(a) Profile view

(b) Plane view

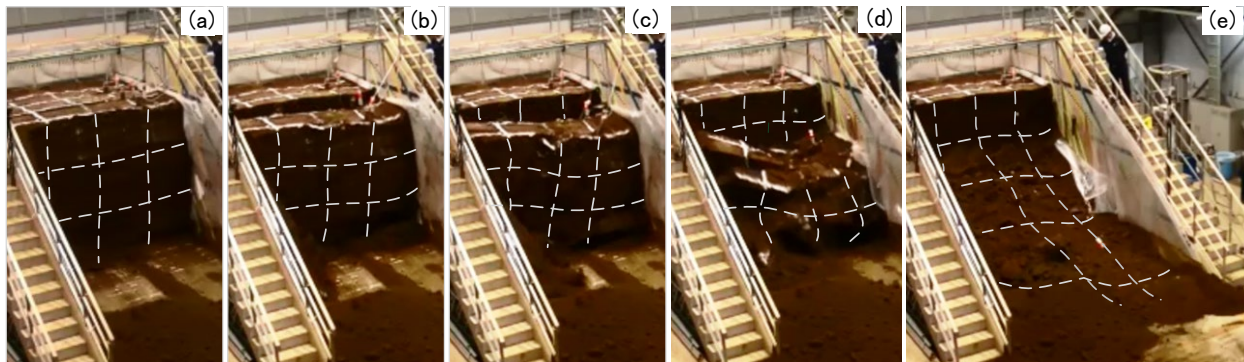
Figure 8 shows the failure process of the excavated wall, illustrated by five pictures taken in about five seconds. Cracks at the top surface were opened up in Figure 8(a). The position of the failure block is also indicated in Figure 7b. Figure 8(b) and (c) show that a mass of soil fell down. The mass separated into smaller pieces (Figure 8(d)). Collapsed soil then spread over the floor (Figure 8(e)). As the remaining slope on the left side was still supporting the trench wall, the shoulder did not move in parallel at the beginning of the failure. However, the entire trench wall failed in the end.

Figure 8. Process of failure of excavated wall in five seconds.

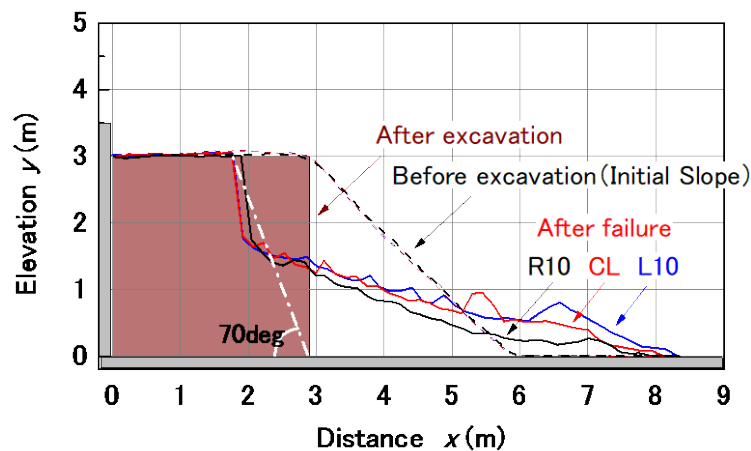
It was impossible for people to detect an increase in risk prior to failure by visual observation of the trench wall. This situation is dangerous as people who work in trenches are not aware of the increase in the threat indicated by the enlargement of the cracks (Tamate & Hori, 2018a). Figure 9 shows the shape of the trench after failure. Since the three curves R10, CL and L10 (see their location on Figure 7) are almost identical, the failure recorded in the lab is similar to plane strain conditions. A vertical wall appeared at an elevation between 1.6 and 3.0 m. The collapsed soil travelled a distance of about 5 m.

Figure 9. Profile shape of slope before and after excavation, and after failure.

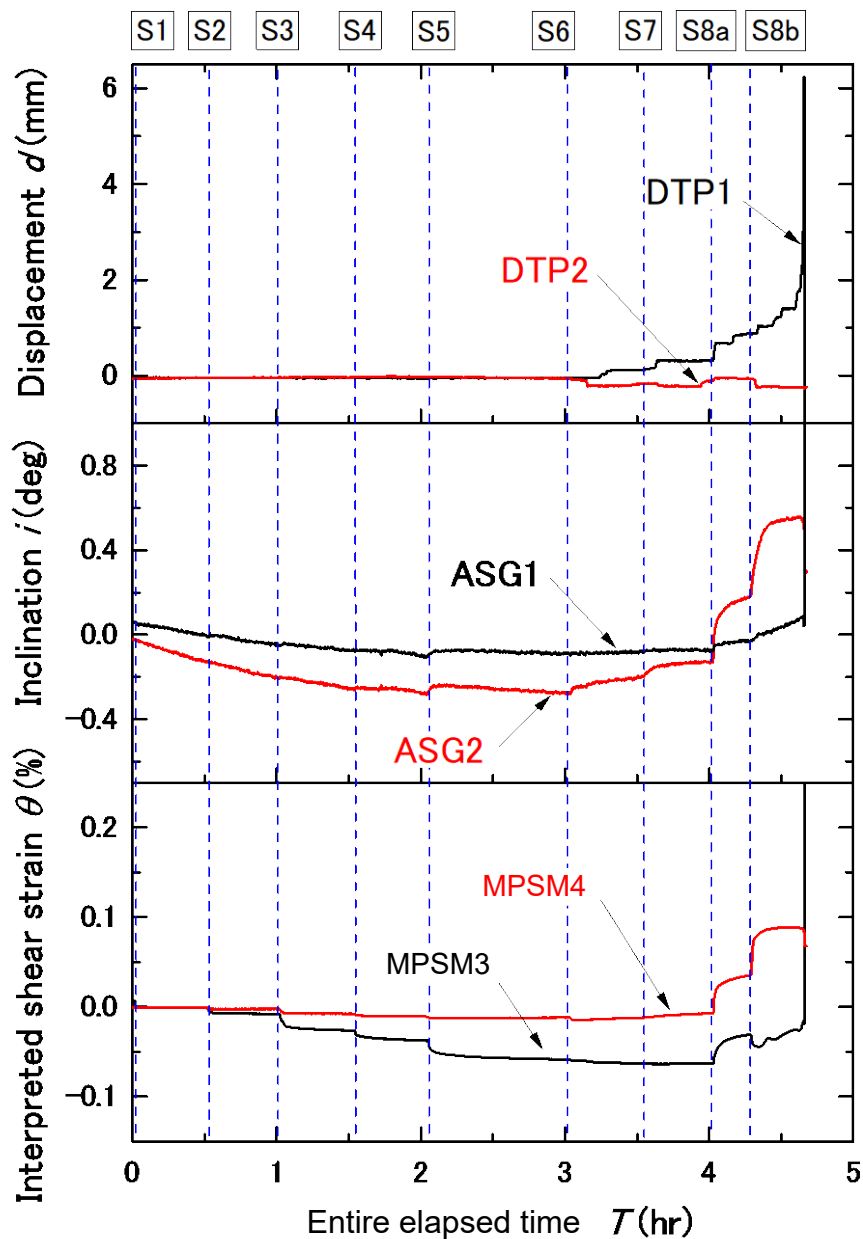
Figure 10 shows the reaction from the three types of sensors – DTP, ASG and MPSM – from the beginning of the excavation until failure. The elapsed time T is shown on the lower horizontal axis. The excavation steps are labelled S1 to S8b on the upper horizontal axis. Fifteen-minute time intervals have been included to indicate a convergence of the increase between S8a and S8b. Two curves in each group of sensors show data that was obtained in two different rows. Experimental results were calculated under equivalent conditions with respect to distance from the shoulder. The excavated wall failed at 4.6 hours, when 23 minutes had passed after S8b of the final excavation step.

Figure 10. Reaction of DTP, ASG and MPSM sensors prior to failure.

An increase in the sensor reaction appeared prior to failure. The value of displacement d on sensor DTP1, which was located 0.8 m away from the shoulder, showed a clear increase after excavation S6. Moreover, the value increased significantly just a couple of minutes before failure. Meanwhile, DTP2 was positioned outside of the failure area (at 1.6 m from the shoulder) and its data did not show a clear increase.

The inclination signal i showed a slow decrease from the beginning of excavation S1. The decrease in ASG2, which was located further away from the shoulder, was greater than that of ASG1. Later on, these two ASG signals started increasing shortly after excavation S6. ASG2 data showed a two-step increment prior to failure while ASG1 showed a quick and large increase at failure following a gradual increase. For the ASG sensors, a larger reaction was recorded for the sensor positioned farther from the shoulder. Therefore, DTP and ASG data show opposite results in the relationship between the magnitude of the reaction and the distance from the shoulder. This could be because the direction of the reactions, which are either vertical or horizontal, are recorded differently by the sensors.

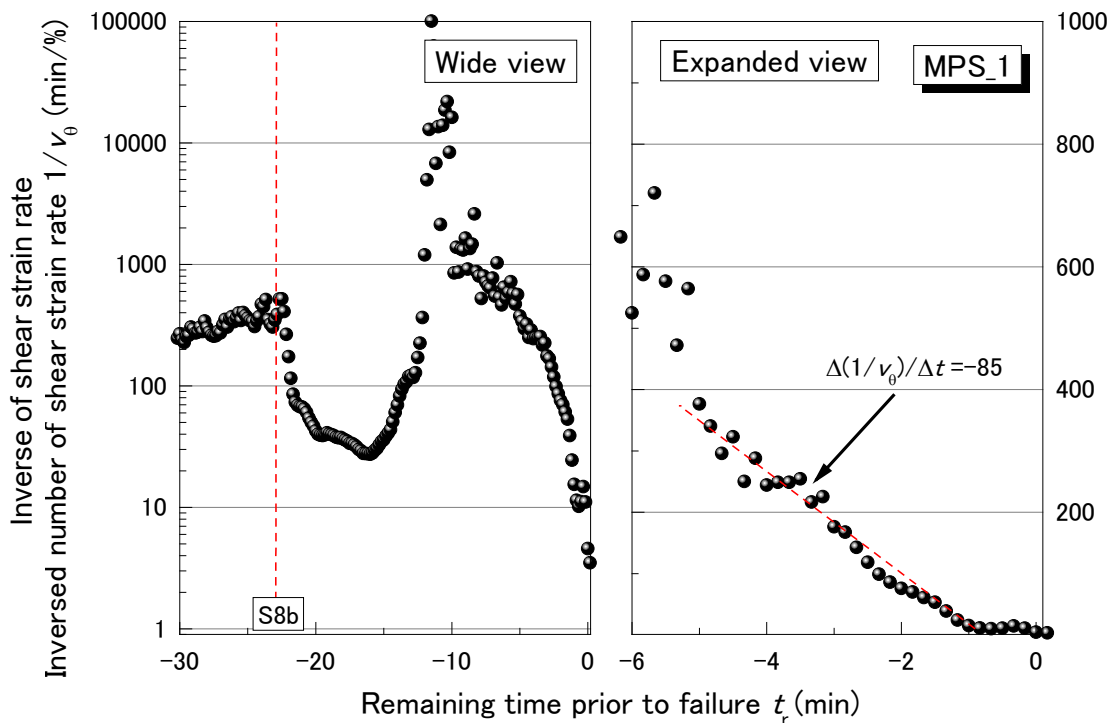
The left side of Figure 11 shows the relationship between the inverse of the shear strain rate $1/v_\theta$ and the remaining time prior to failure t_r on a logarithmic scale on the vertical axis. In this figure, v_θ is defined as the per-minute value of the increment of θ . Zero value for t_r corresponds to the trench failure time. Negative values of t_r indicate the remaining time prior to the failure. It can therefore be regarded as a type of velocity. When t_r was -10 , the $1/v_\theta$ values of MPSM1 were distributed at over 1000 min/%. This means that less than 0.001%/min of v_θ appeared 10 min before failure. However, $1/v_\theta$ shows a drastic decrease, whereas v_θ increased, when t_r went from -10 to 0 min.

The right side of Figure 11 provides an expanded view according to a linear scale on the right side vertical axis, showing $1/v_\theta$ values between 10 and 400 min/% when t_r was between -5 and -1 min. The values of v_θ were calculated as being between 0.0025 and 0.1 %/min. Consequently, in the same manner as for the second creep, the shear strain mostly accelerated in its increase. Accordingly, a clear increase in shear strain in the shallow subsurface was confirmed in the full-scale test model. In addition, it was proven that this phenomenon reflects an increase in potential threat of trench failure. Therefore, detecting creep phenomena would provide workers with a couple of minutes to escape.

Figure 11. Inverse of velocity of shear strain as provided by MPSM1.

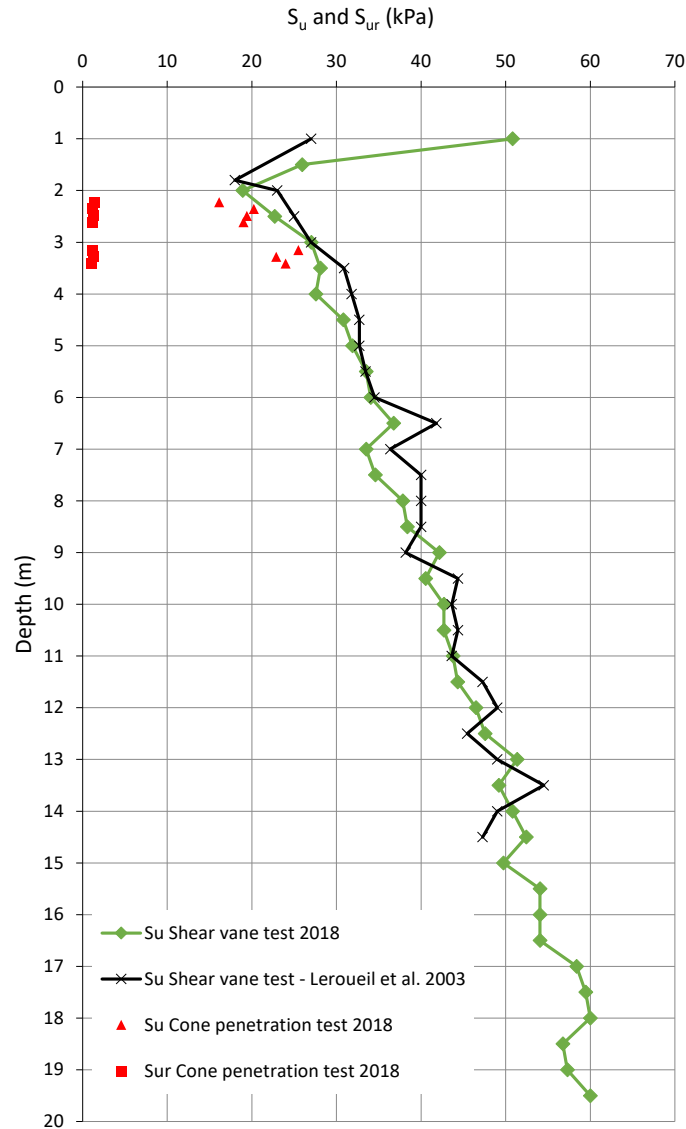
Figure 13 shows the undrained shear strength (S_u) and the residual undrained shear strength (S_{ur}) of the MTMDET's Louisville site, as measured by the IRSST and Laval University in 2018, and compared to the values obtained by Leroueil et al. (2003). Undrained shear strength values were obtained with either the shear vane test or the cone penetration test (CPT).

Figure 13. Undrained shear strength (S_u) and residual undrained shear strength (S_{ur}) of Louisville clay.

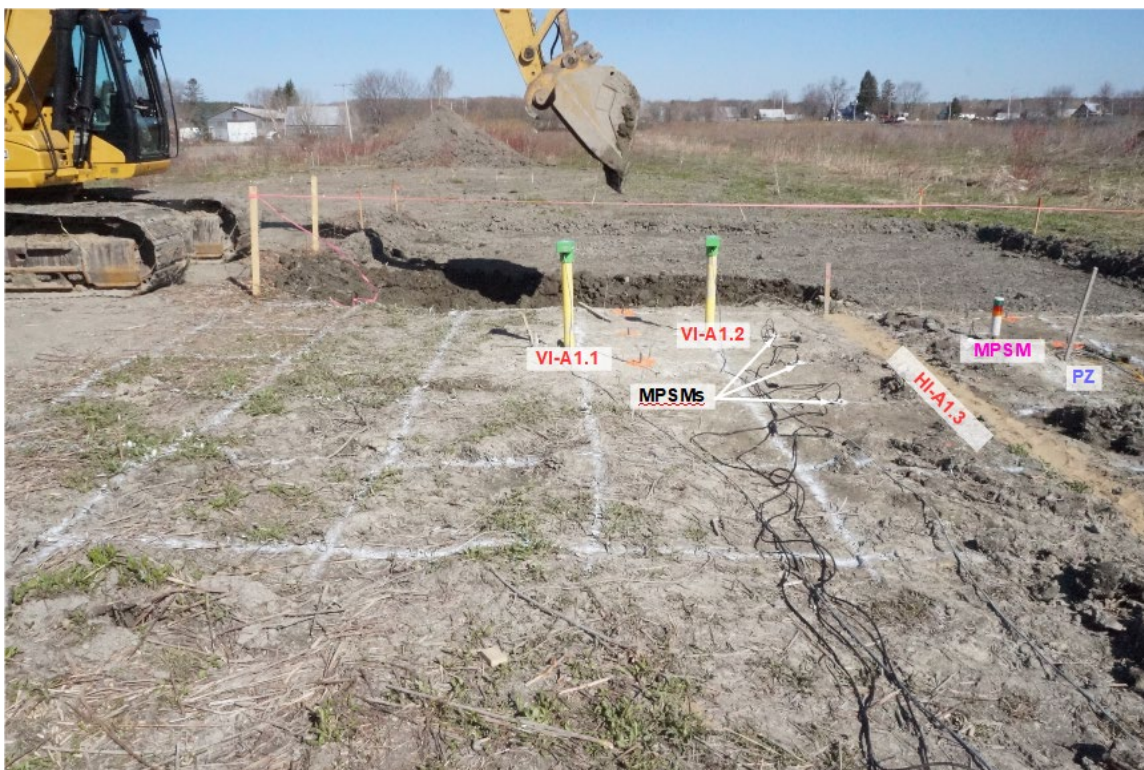
Figure 16. Excavation of trench A1.

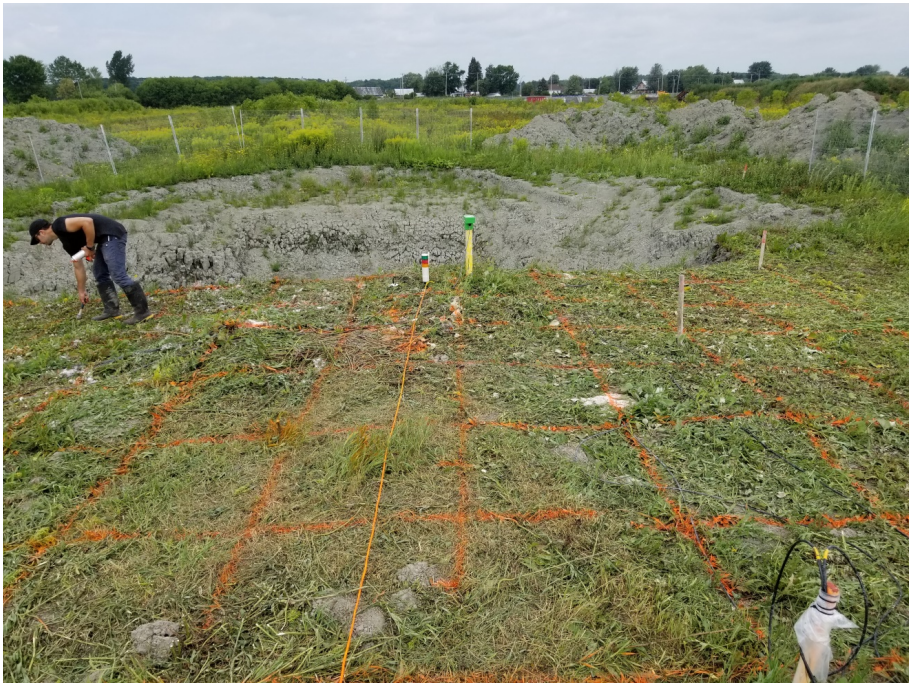
Figure 19. Trench A2 with a rectangular pattern marked with orange paint to monitor ground movement.

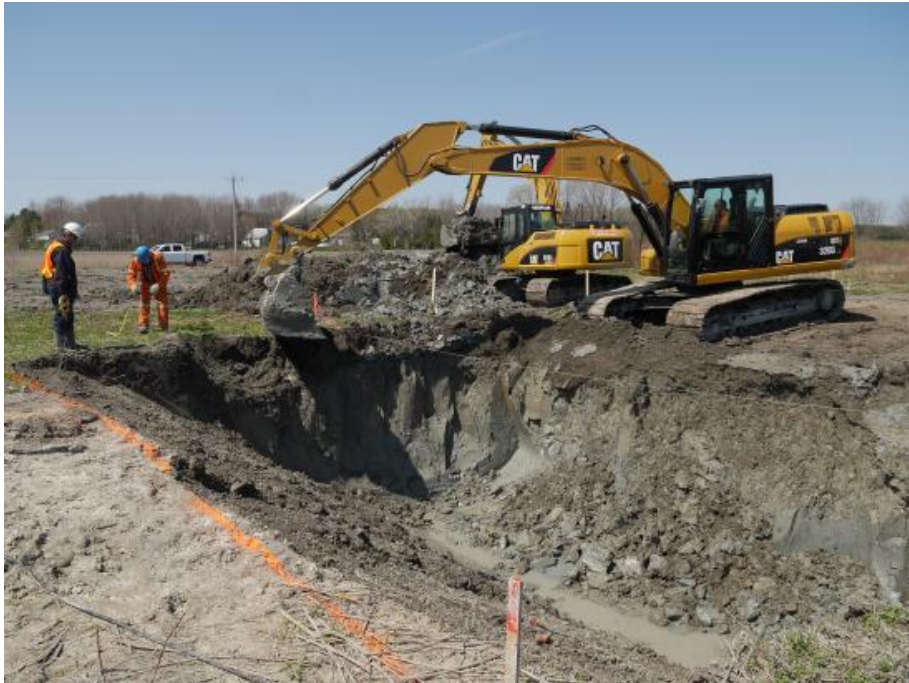
Figure 20. Digging of trench A2 with Caterpillar 315 and Caterpillar 320 excavators.

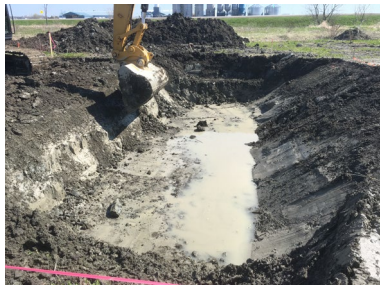
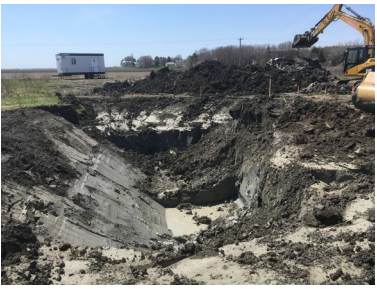
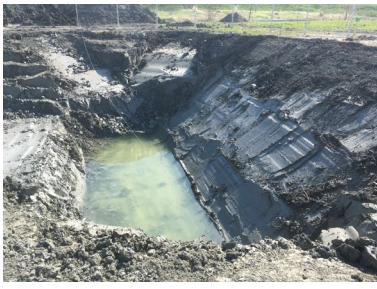
Step 2 Depth: 2 m 9:55 am	Step 3 Depth: 4.18 m 2:22 pm	Final Depth: 4.18 m 3:48 pm
Step by step excavation with 1.5:1 slope, with water infiltration in oxidized clay	Maximum depth for mechanical excavator used on site	Resulting trench A2

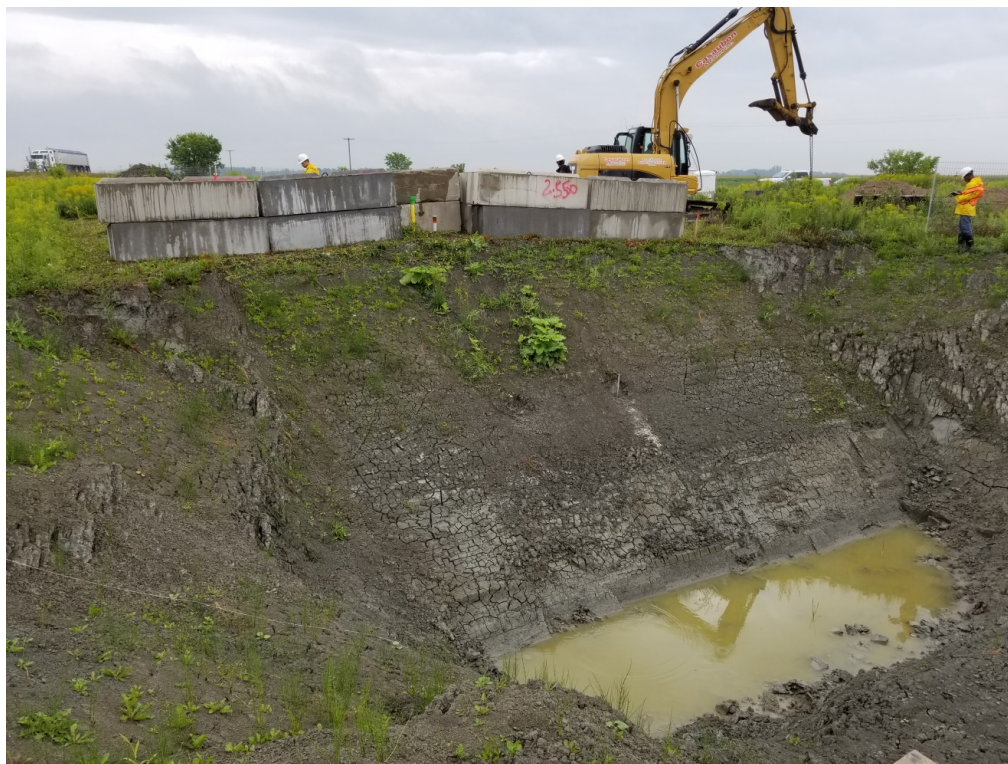
Trench A2 was left open for three months. In order to simulate a 6 m deep wall, the 1.6:1 wall was loaded with concrete blocks and sand during the week of August 6, 2018. The 1.6:1 wall was initially loaded with concrete blocks (Figure 23) following a first (Figure 24) and a second (Figure 25) loading patterns.

Figure 23. Loading of trench A2 with concrete blocks.

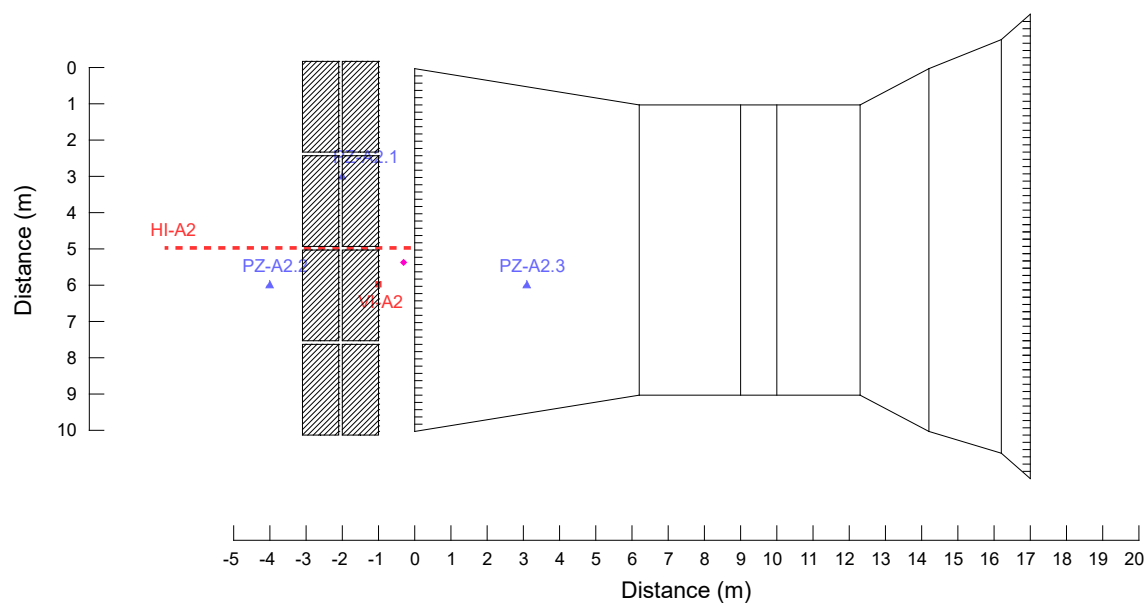
Figure 24. First loading pattern of trench A2 with concrete blocks.

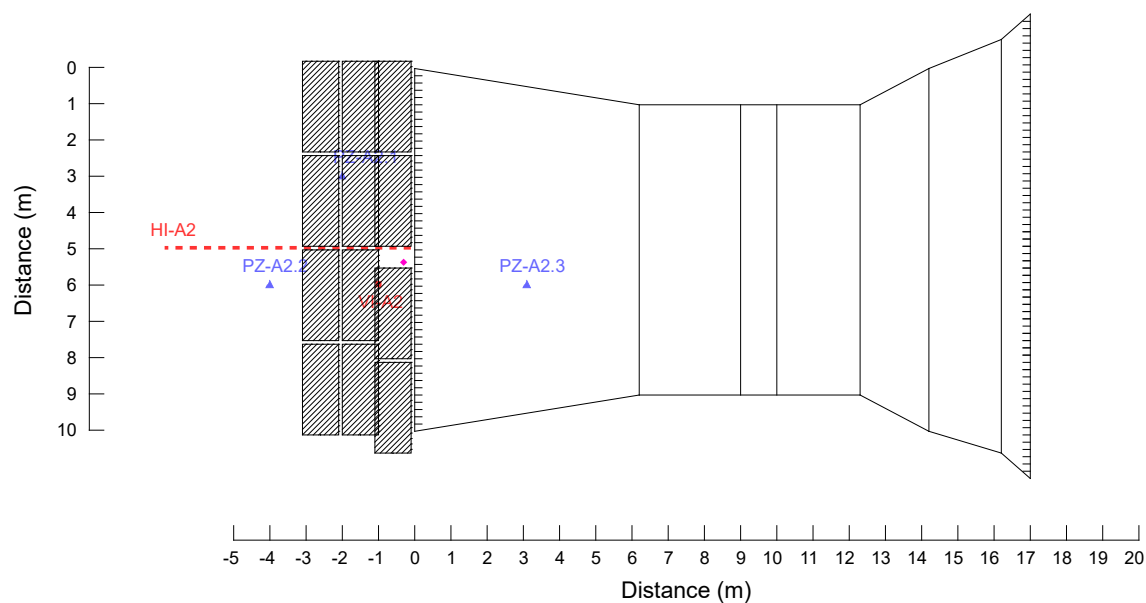
Figure 25. Second loading pattern of trench A2 with concrete blocks.

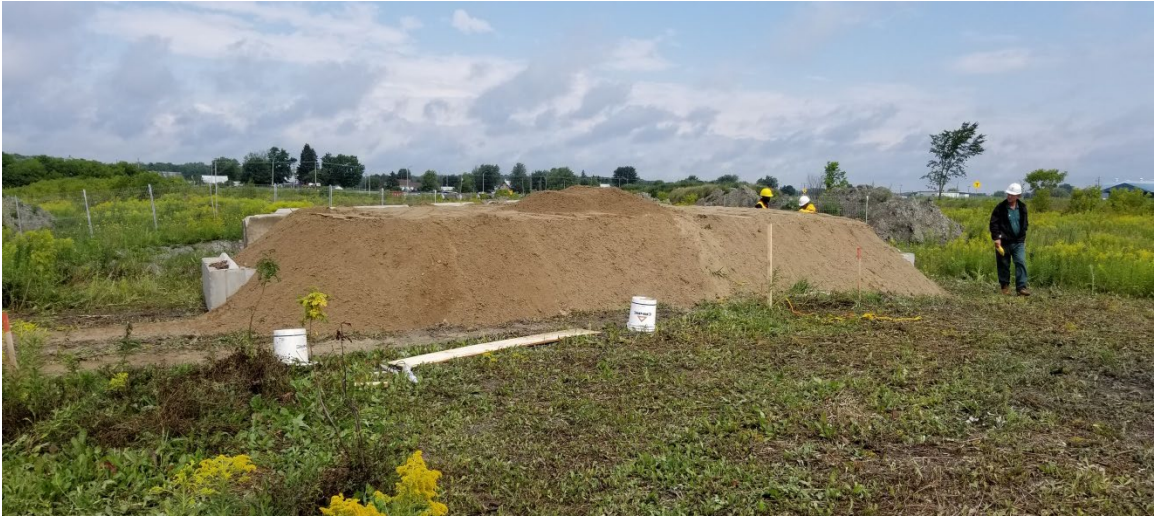
The surcharge for the 1.6:1 wall was then reaching approximately 30 kPa when sand was added next to the concrete blocks, as shown in Figure 26 and Figure 27.

Figure 26. Loading of trench A2 with concrete blocks and sand.

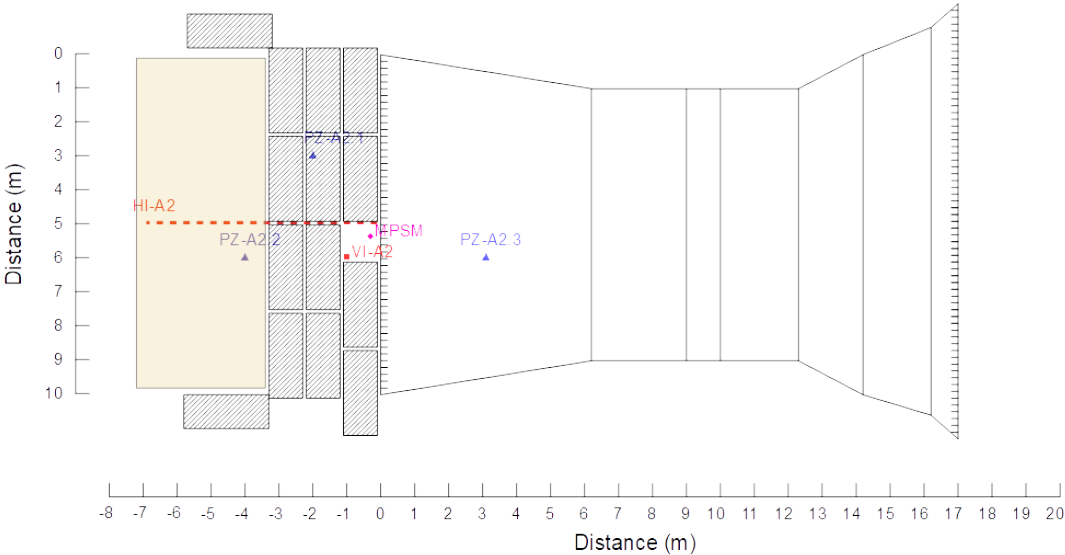
Figure 27. Additional loading of trench A2 with sand.

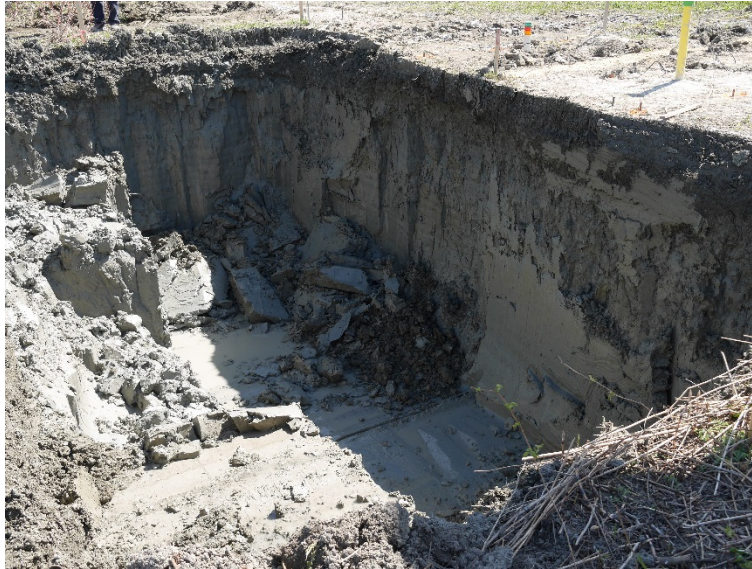
Excavation of trench A1 began on May 8, 2018, at around 9:00 a.m. At around 9:34 a.m. (approximately step 3 on Figure 17), at a depth of 2 m, a vertical rupture due to flaking and fragmentation of weathered brown clay and water inflows in the oxidized clay was observed (Figure 28).

Figure 28. Rupture due to flaking and water inflow during excavation of trench A1 (step 3).

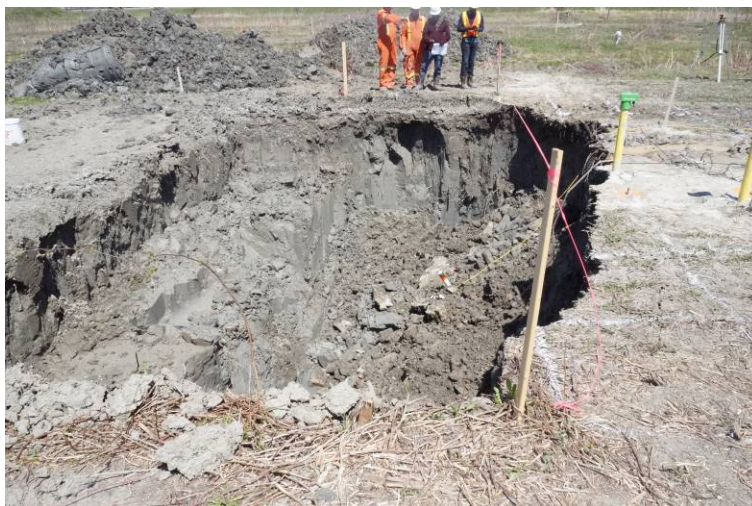
The flashing yellow light of the MPSM came on to indicate detection of the second creep phenomenon of D1 around 12:06:15 (step 5), which lasted 22 minutes. At 12:27:18, the flashing red light of the MPSM came on to indicate detection of the third creep phenomenon, which lasted 22 seconds, and a large block of soil broke away, causing the wall to recede by 1 m. The JNIO SH alarm unit was carried away with debris to the bottom of the trench (Figure 29). The trench was left untouched for about 2 hours and step 6 began at 14:34.

Figure 29. Rupture of vertical wall at a depth of 5 m, carrying the MPSM to bottom of the trench.

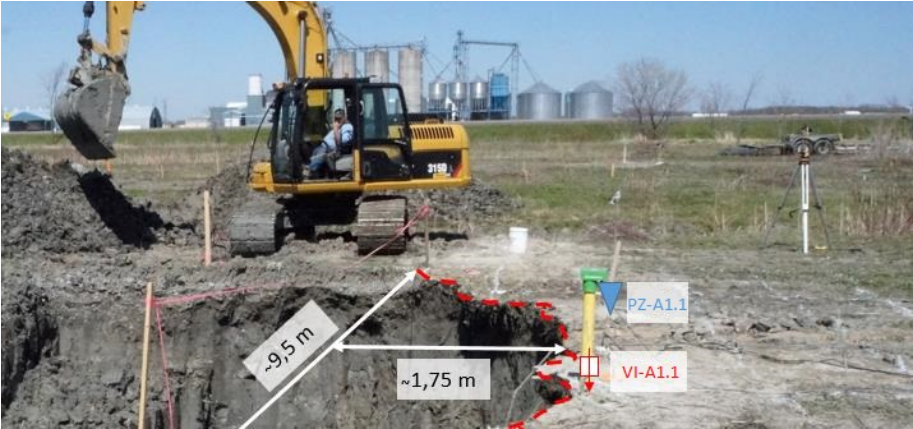
from the bottom of the trench prior to the excavation of step 6. As the trench stability was questionable, for safety reasons, the researchers did not proceed to the reinstallation of the MPMSM at the shoulder of the trench. Thus, it was not possible to assess the ability of the MPMSM to predict the trench collapse for step 6.

Figure 30. Major block of soil broke away, causing the wall to recede by 1.75 m.

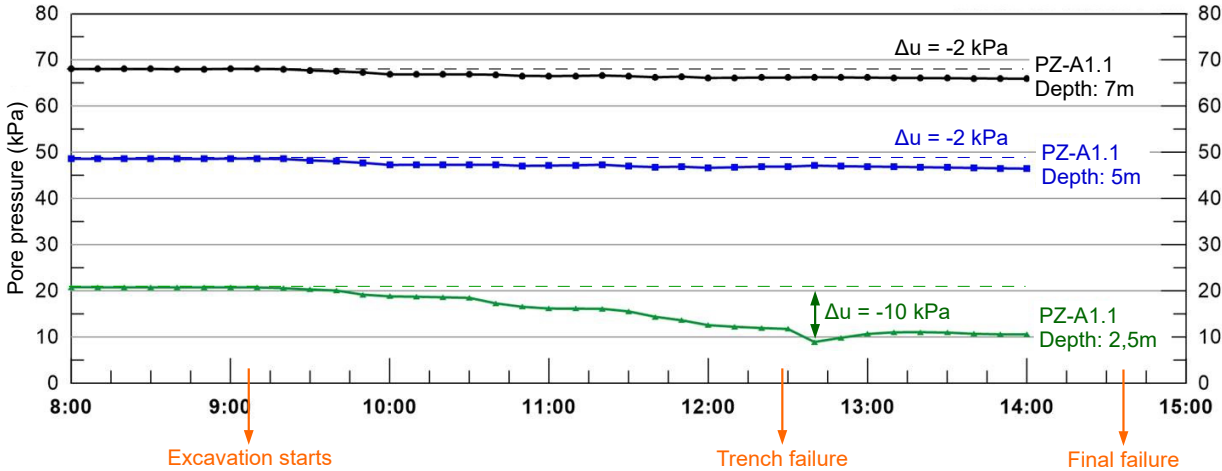
Figure 31 shows the piezometer results for the collapse of trench A1 on May 8, 2018.

Figure 31. Piezometer results for trench A1, during excavation on May 8, 2018.

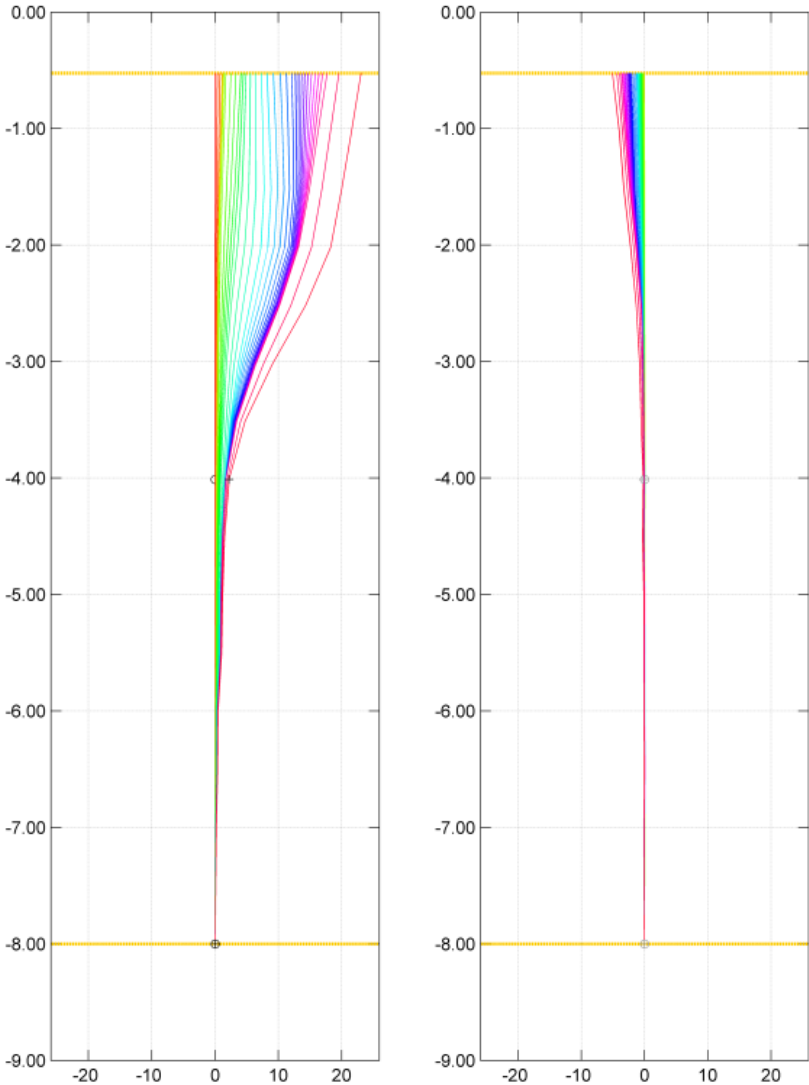
Figure 32, Figure 33 and Figure 34 show the results for the inclinometers VI-A1.1, VI-A1.2 (both vertical) and HI-A1.3 (horizontal) respectively. The two vertical inclinometers show a maximum horizontal displacement ΔX of 45 mm at the top for the closest inclinometer to the vertical wall of the trench (VI-A1.2) and of 23 mm at the top for the other one (VI-A1.1). The inclinometer tubes were protruding 0.5 m above the soil level, meaning that at a depth of 3.5 m, no noticeable horizontal displacement was measured by the instruments. The ΔY displacements were quite limited (around 5 mm), indicating that the vertical wall displacement was relatively symmetrical. The horizontal inclinometer measured a 20 mm vertical displacement of the soil.

Figure 32. Vertical inclinometer VI-A1.1 (left = ΔX , right = ΔY , results in mm).

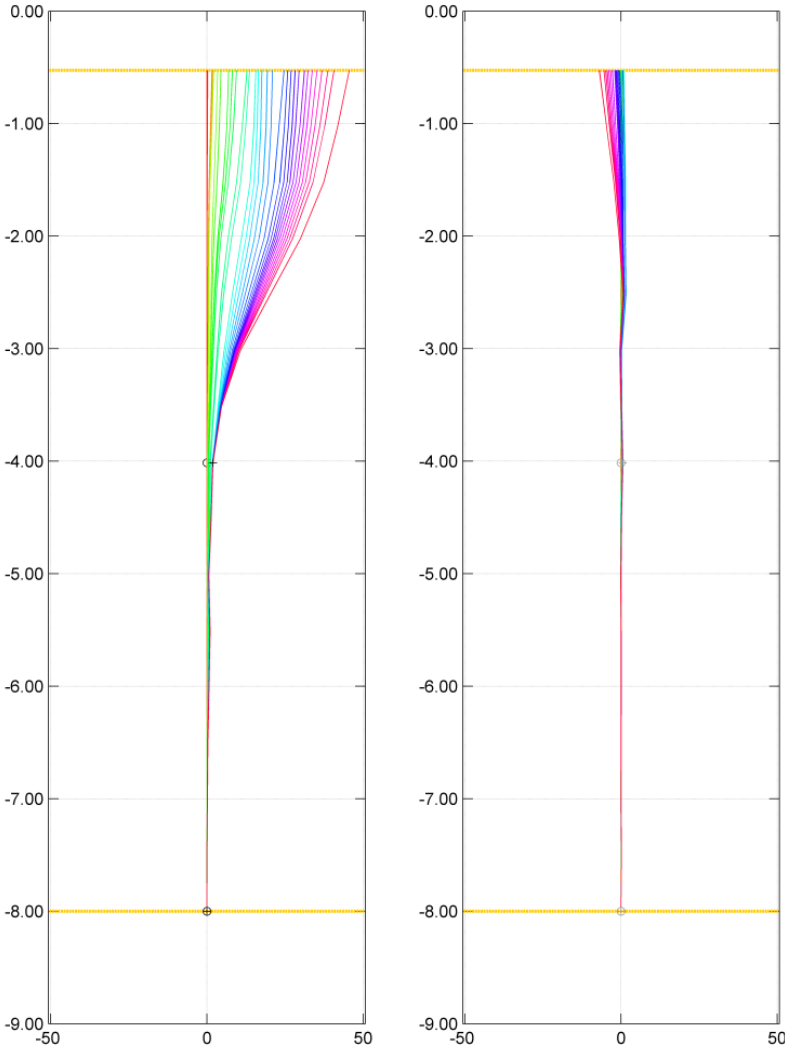
Figure 33. Vertical inclinometer VI-A1.2 (left = ΔX , right = ΔY , results in mm).

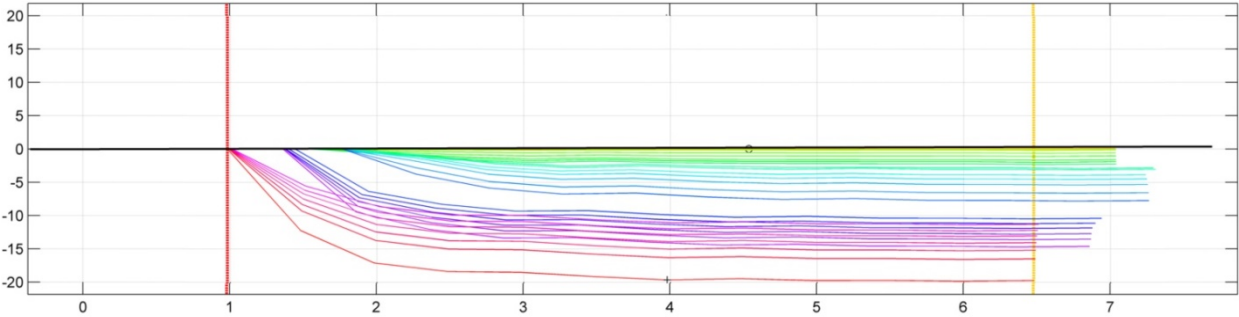
Figure 34. Horizontal inclinometer HI-A1.3 (results in mm).

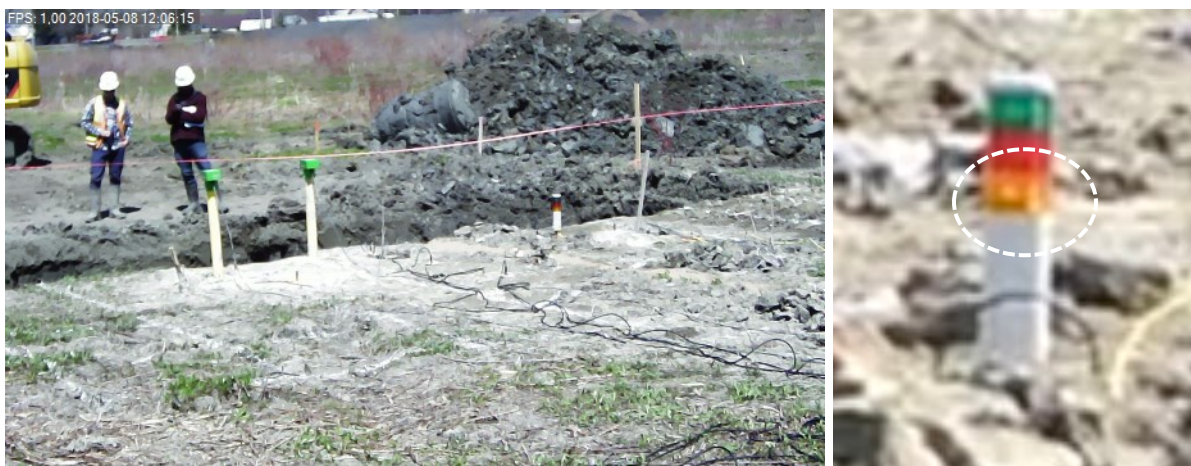
Figure 35 shows the flashing yellow light of the D1 warning, following the detection of the second creep phenomenon, while Figure 36 shows the flashing red light of the D2 warning, following the detection of the third creep phenomenon.

Figure 35. Flashing yellow light of D1 warning, following the detection of the second creep phenomenon prior to failure.

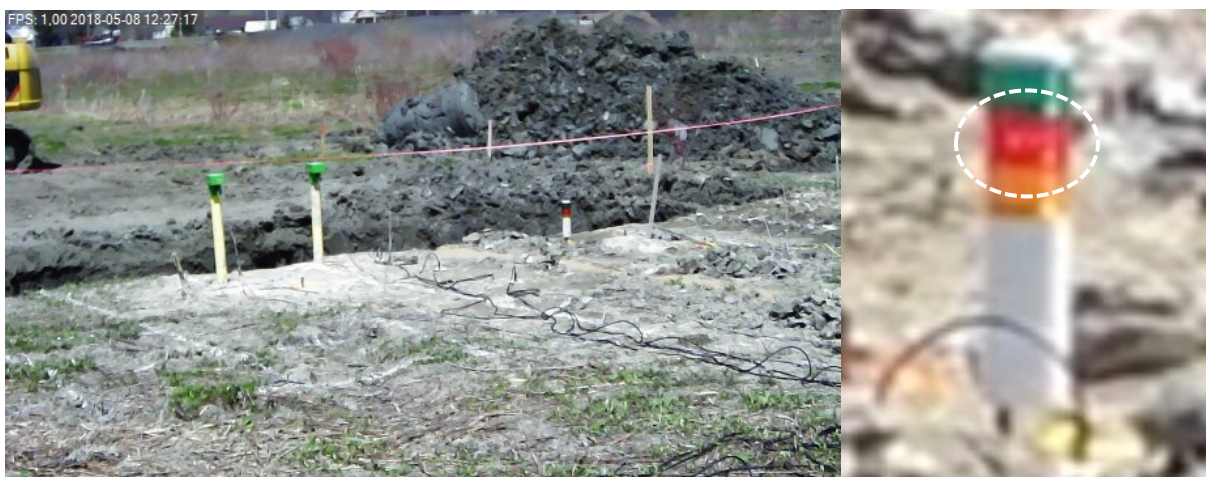
Figure 36. Flashing red light of D2 warning, following the detection of the third creep phenomenon prior to failure.

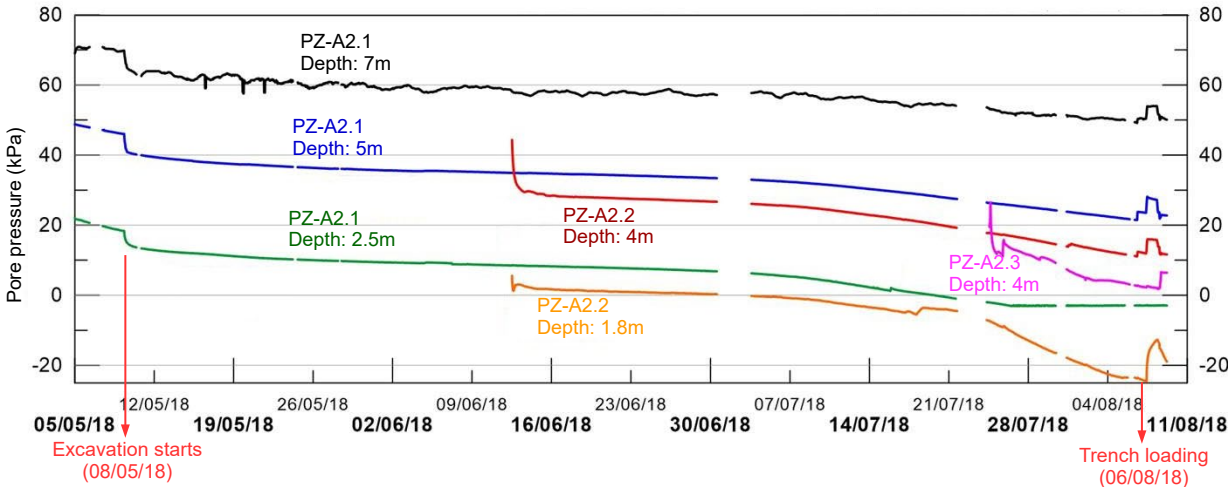
Figure 37 shows the trench A2 piezometer results for the period from May 5 to August 11, 2018. The loading of the concrete blocks was done on August 6, 2018. As can be seen from the piezometer data, pore pressure declined throughout the summer, which suggests that the horizontal stress in the soil was gradually released as the summer progressed. It is worth noting that the water table was approximately 0.5 m below the soil surface in early May and around 2.5 m below the surface in August. As mentioned in Section 5.1, the summer of 2018 was warmer and dryer than usual. An increase in pore pressure was recorded on August 6, which corresponds to the 30 kPa load applied to the top of the trench.

Figure 37. Results of the piezometers A2.1, A2.2 and A2.3 for the period from May 5 to August 11, 2018.
