Field test of the JNIOSH Mini Pipe Strain Meter as a safety alert system during trench work

STUDIES AND
RESEARCH PROJECTS

R-1124-en

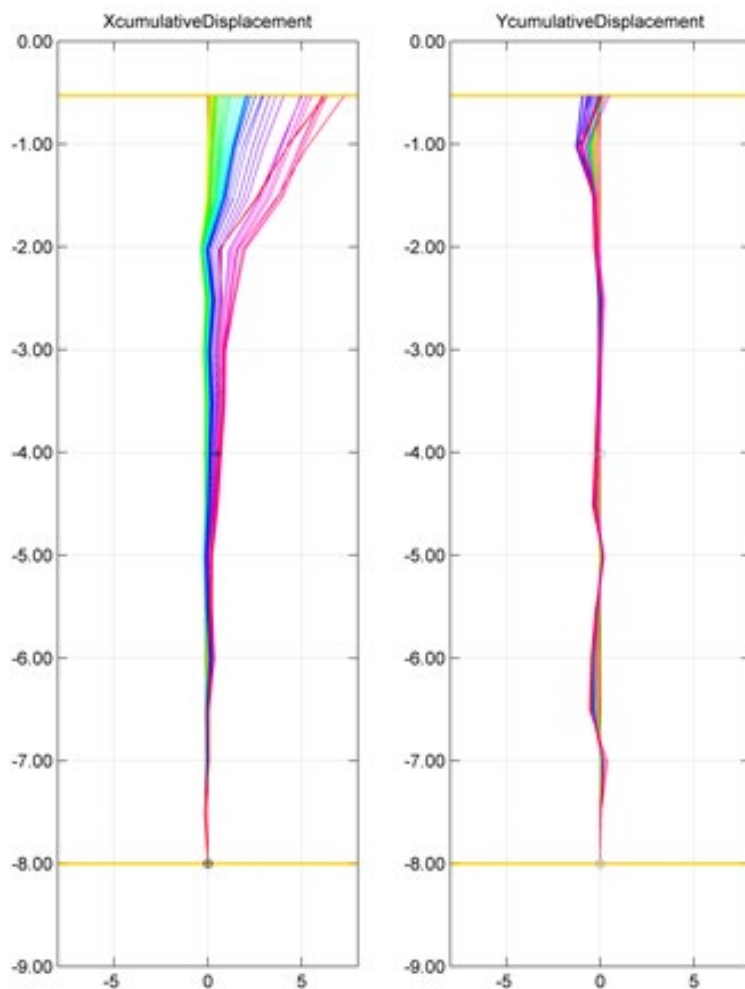
Figure 38 shows the vertical inclinometer (VI-A2) results. The vertical inclinometer recorded a small horizontal displacement (7 mm) at the top of the trench, but almost no displacement at the bottom of the trench (depth of 4.2 m).

Figure 38. Vertical inclinometer results (VI-A2) for trench A2 (left = ΔX , right = ΔY , results in mm).

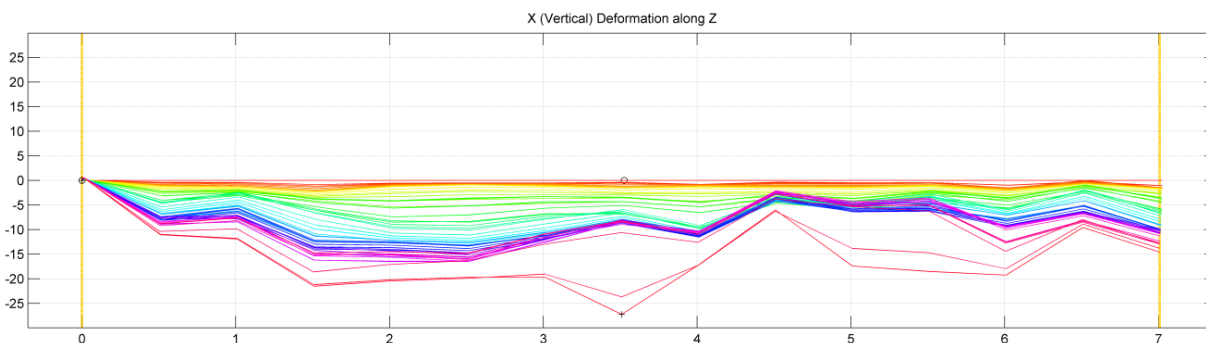
Figure 39. Horizontal inclinometer (HI-A2) results for trench A2 (results in mm).

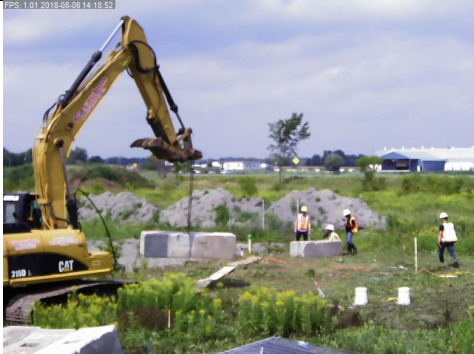
A yellow CAT excavator is shown in the process of lifting a concrete block. The site is an open field with some vegetation and a few workers in the background.

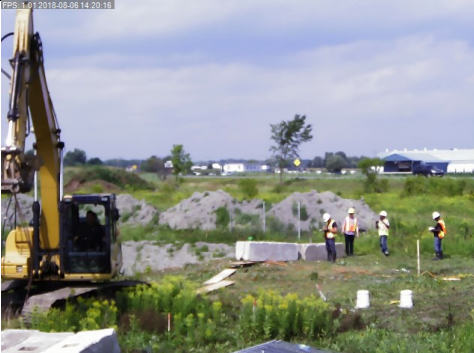
14:20:17	D1 and D2	Placing concrete blocks in close proximity (first row)

The excavator is positioned over a row of concrete blocks, carefully placing them. Several workers are standing nearby, observing the process.

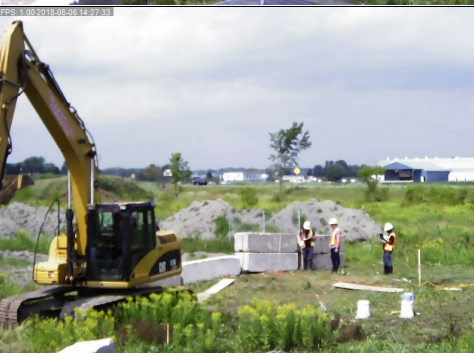
The excavator is now placing a second stack of concrete blocks on top of the first row. The workers are still present, monitoring the operation.

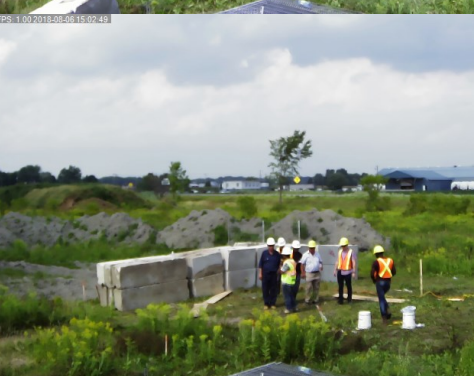
The final state of the trench area, showing two rows of concrete blocks, each with two stacks. Workers are gathered around the trench, and the excavator is no longer visible.

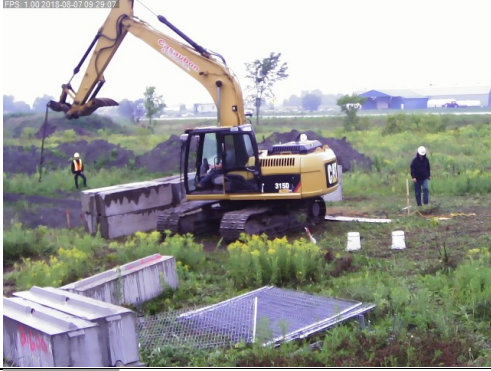
9:42	Placing the side blocks of concrete

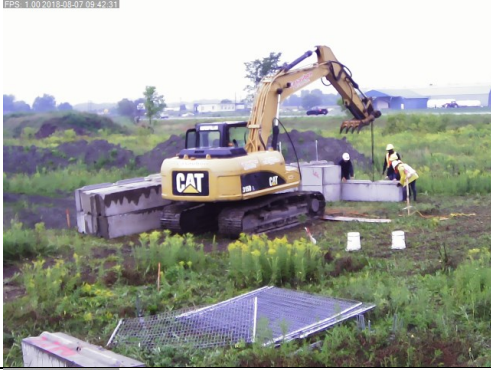
9:50	Loading with sand

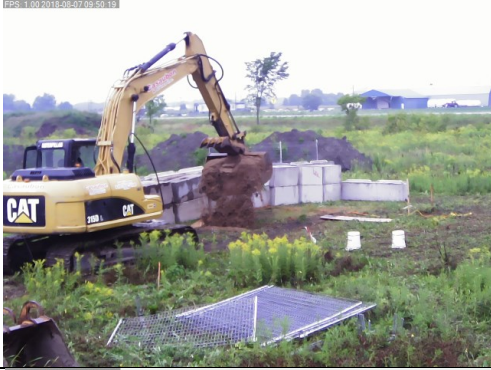
11:10	End of loading (rain started at around 10:15)

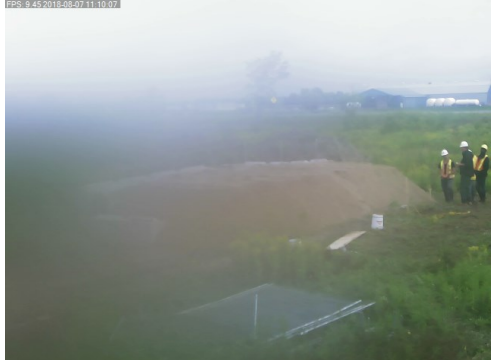
Figure 40. MPSM results during trench A2 loading, showing two specific loading periods (Day 1 and Day 2).

The MPSM was installed at the top of the trench on August 6, at 10:42 a.m. (Day 1). The loading began at 2:15 p.m. on the same day. The recording was stopped on August 8 at 9:00 a.m., giving a total recorded time of approximately 46 hours (Figure 40). Notable events occurring throughout this recording period are listed in Table 8 for Day 1 and in Table 9 for Day 2.

As can be seen from Figure 40, a slight increase in shear strain was recorded shortly after the MPSM was installed in the ground, as the soil settled around the MPSM sensor. Then, at the beginning of the loading of the trench with concrete blocks, a clear increase in shear strain can be noted over approximately four hours after the installation of the MPSM. The device's alarm went off twice (Table 8), corresponding to the placement of blocks in close proximity to the MPSM sensor. Those two events are also observable in Figure 41, as well as in Figure 42, when the inverse of the shear strain rate ($|1/v_{\theta}|$) fell below 100 min/%.

After the initial loading on Day 1, the trench was left to settle for approximately 18 hours. A slight gradual increase followed by a slow decrease in interpreted shear strain can be seen during that period (Figure 40, shown between the two loading days).

Figure 43 shows the interpreted shear strain as a function of time, for the second loading of trench A2, on Day 2. First, a third row of concrete blocks was put in place, nearer to the edge of the trench. This loading did not have a clear effect on the interpreted shear strain. Once the third row of blocks was in place, sand was loaded at the back of the rows of blocks. A decrease in interpreted shear strain was initially recorded during loading, and when the soil deposit was left to settle, the interpreted shear strain increased again until 6:00 p.m. (18:00). Then the interpreted shear strain declined throughout the night and seemed to have stabilized by the morning (Figure 40, $t_e \approx 45$ hrs).

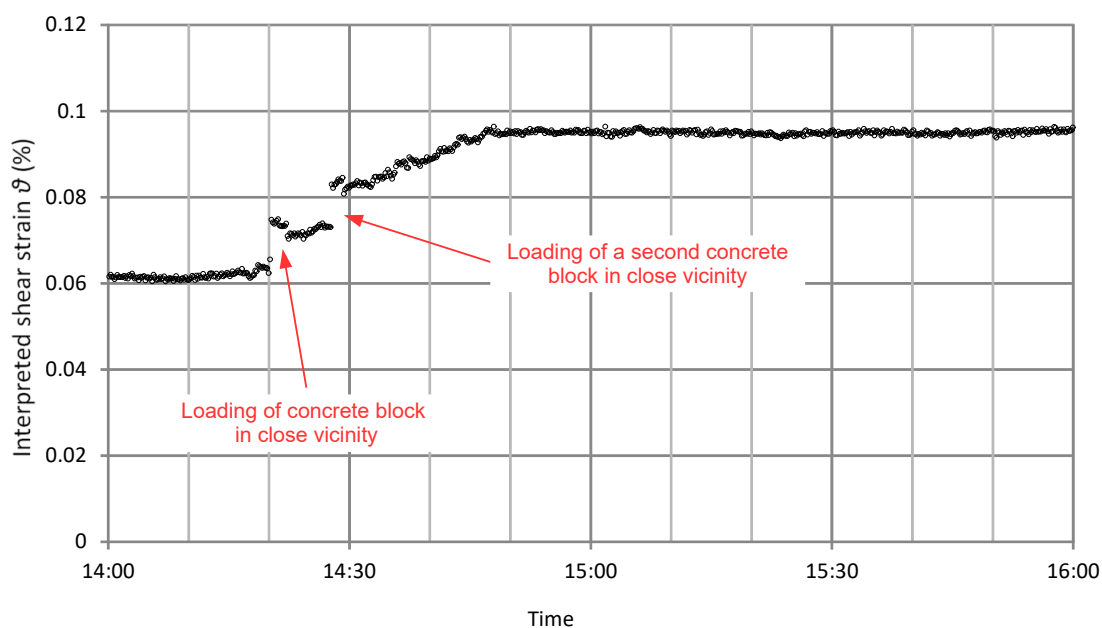
Figure 41. MPSM results during first loading of trench A2 with concrete blocks, showing the effect of placing blocks in the close vicinity of the device.

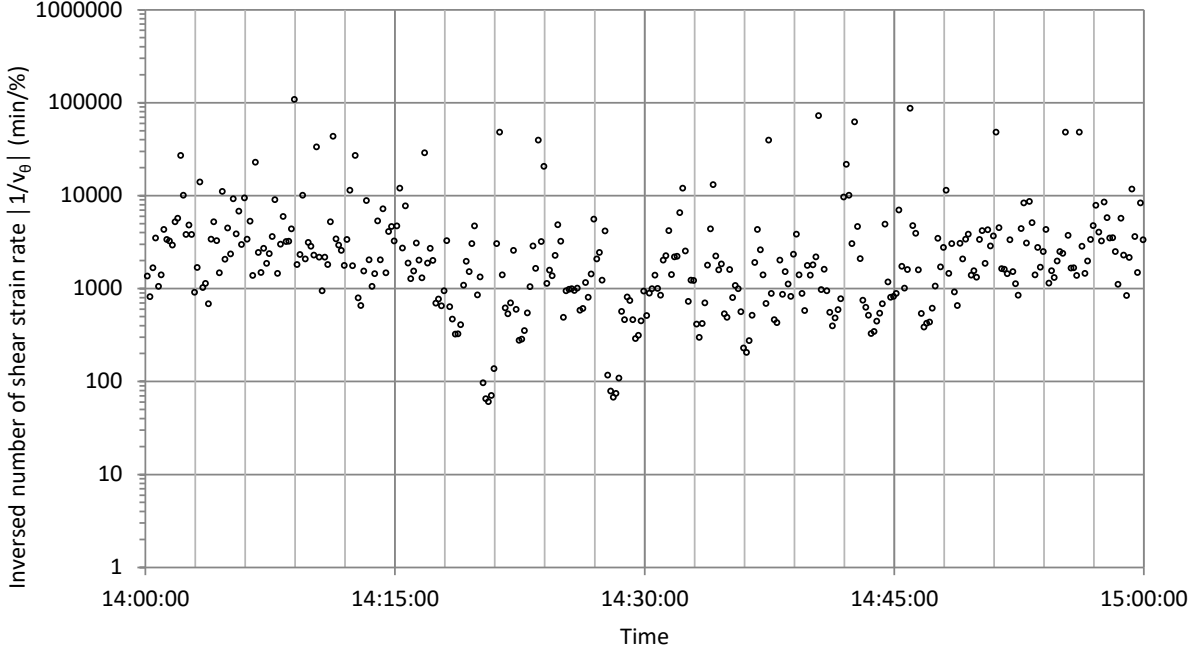
Figure 42. Inverse of shear strain rate $|1/v_{\theta}|$ as a function of time for trench A2 during the first loading with concrete blocks (Day 1).

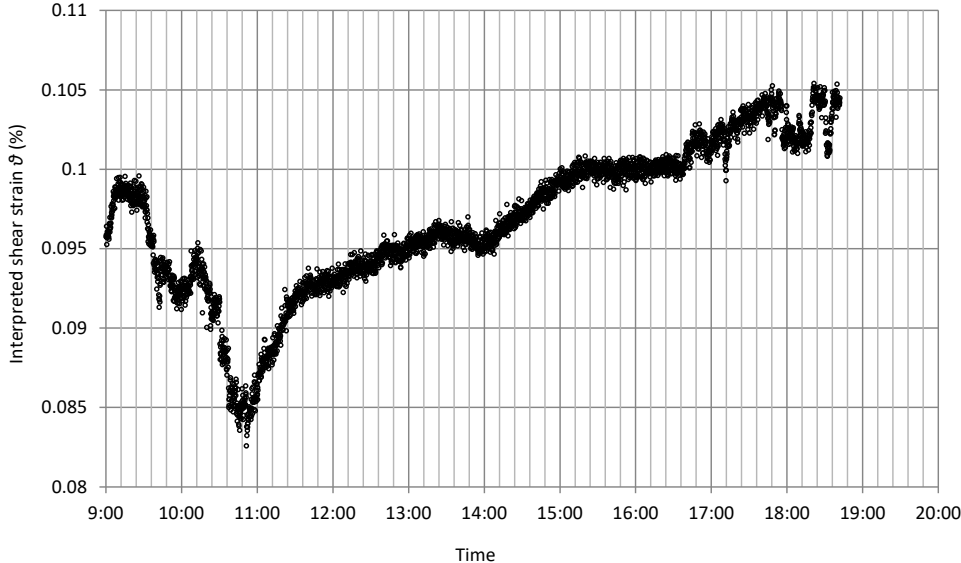
Figure 43. MPSM results during second loading of trench A2 with concrete blocks and sand.

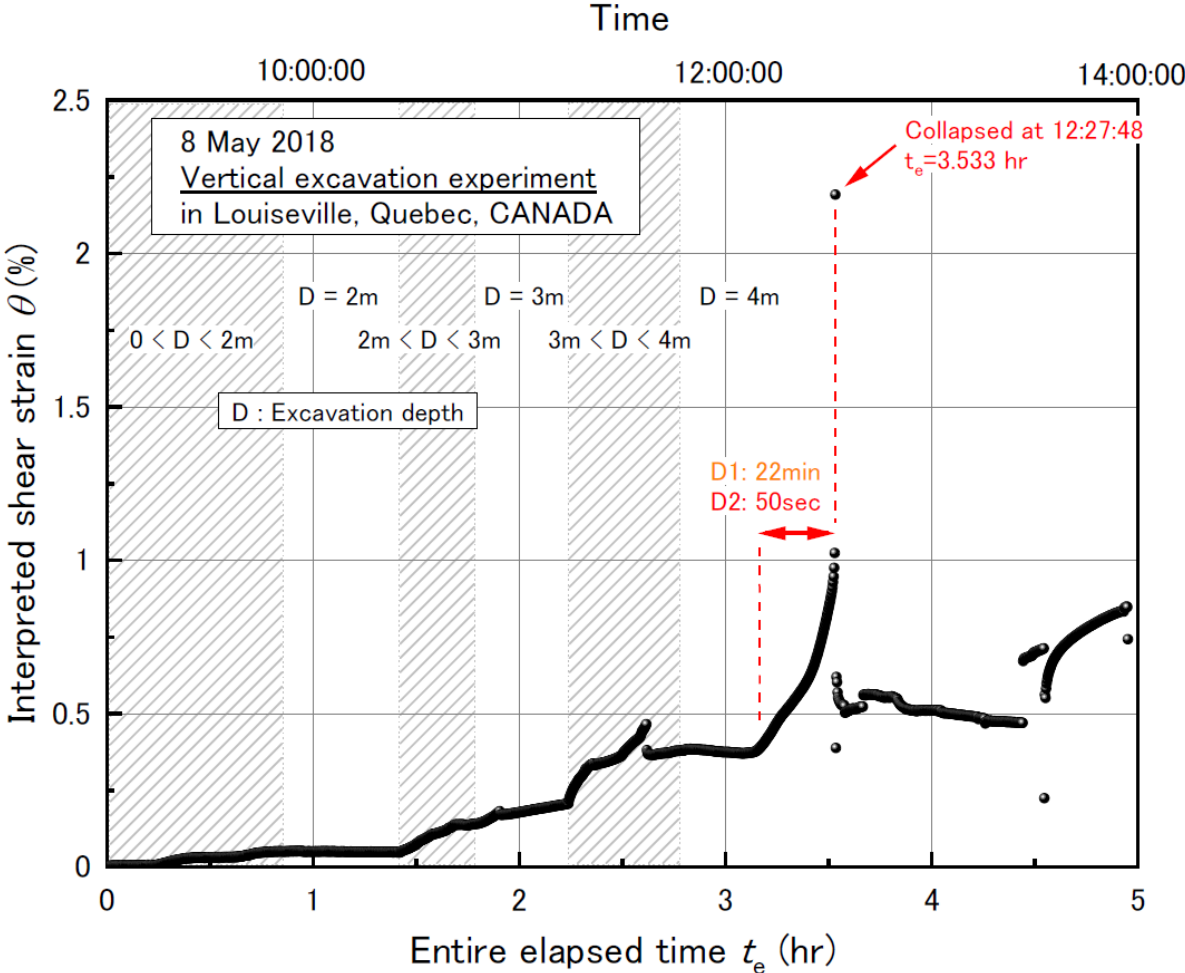
Figure 44. Relationship between interpreted shear strain θ and the entire elapsed time.

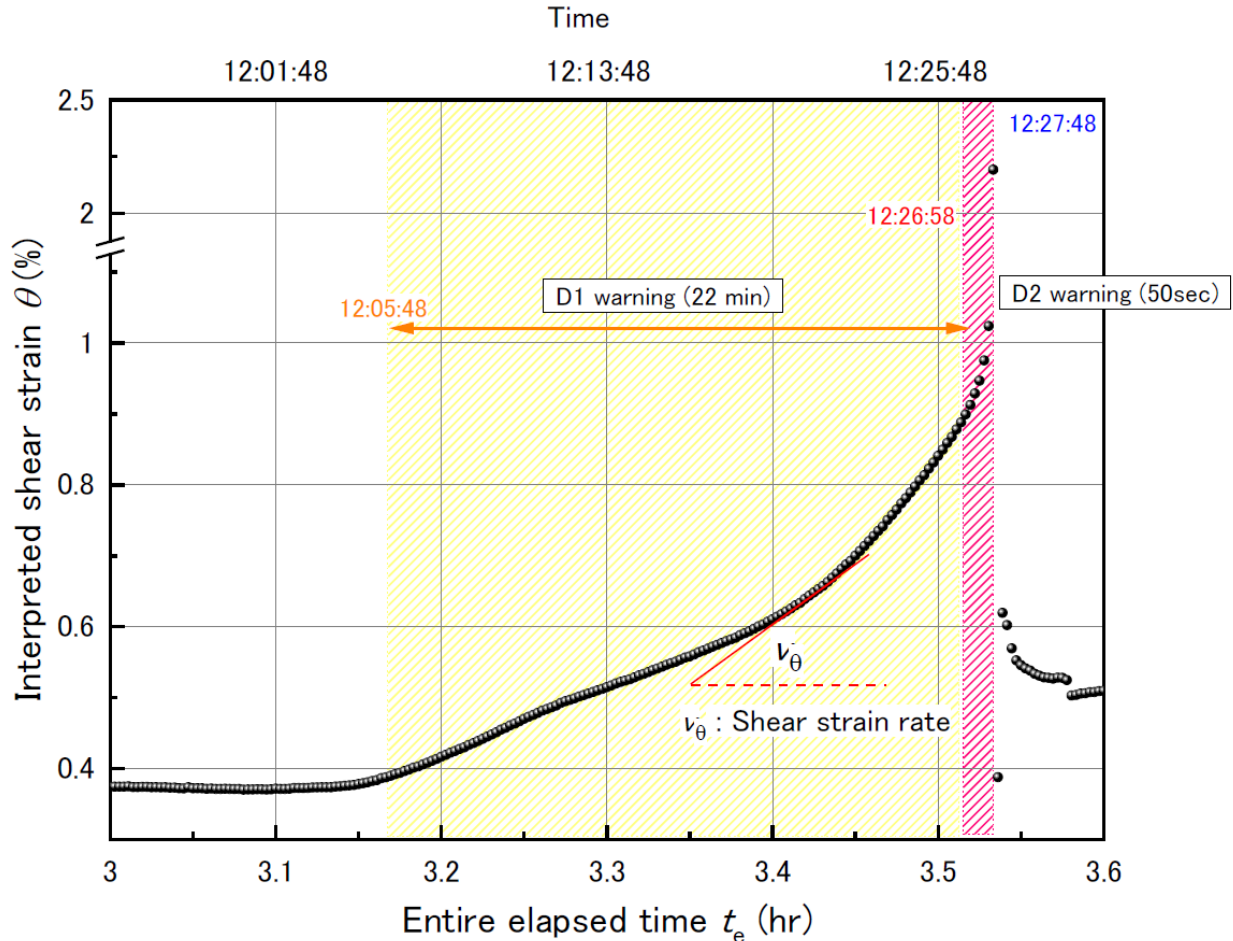
Figure 45. Expanded view of relationship between θ and the elapsed time (t_e) prior to failure.

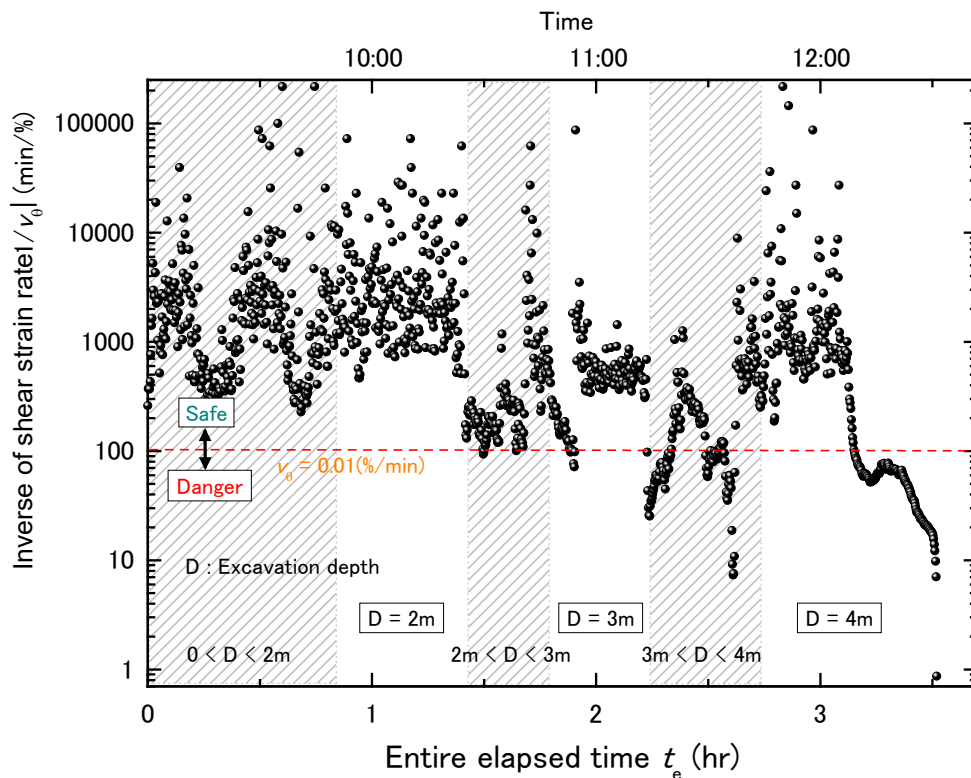
Figure 46. Relationship between inverse of shear strain rate $|1/v_\theta|$ and entire elapsed time t_e .

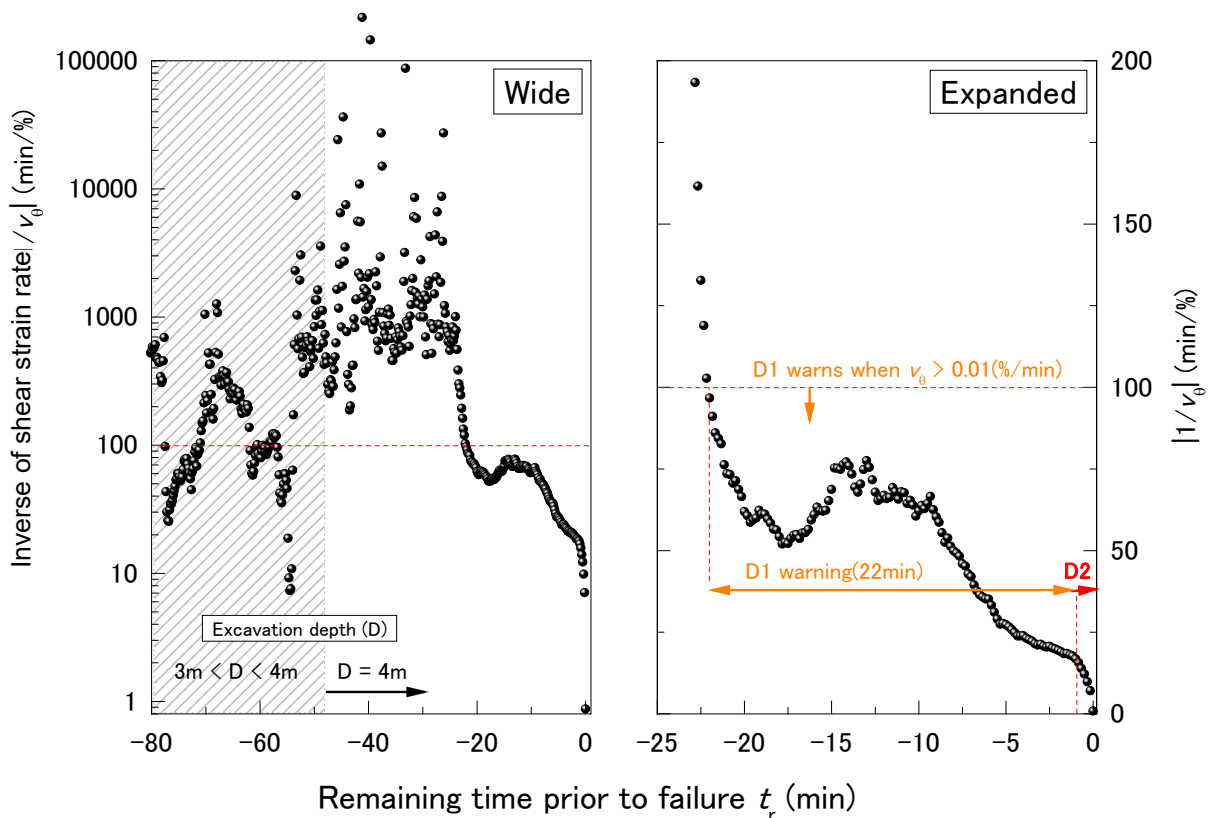
Figure 47. Expanded view of relationship between the inverse shear strain ($|1/v_\theta|$) and the remaining time prior to failure (t_r), for 80 minutes prior to failure (left panel) and for 25 minutes prior to failure (right panel).
