REPORT R-858

## Wind Energy Sector

Occupational Health and Safety Risks  
and Accident Prevention Strategies

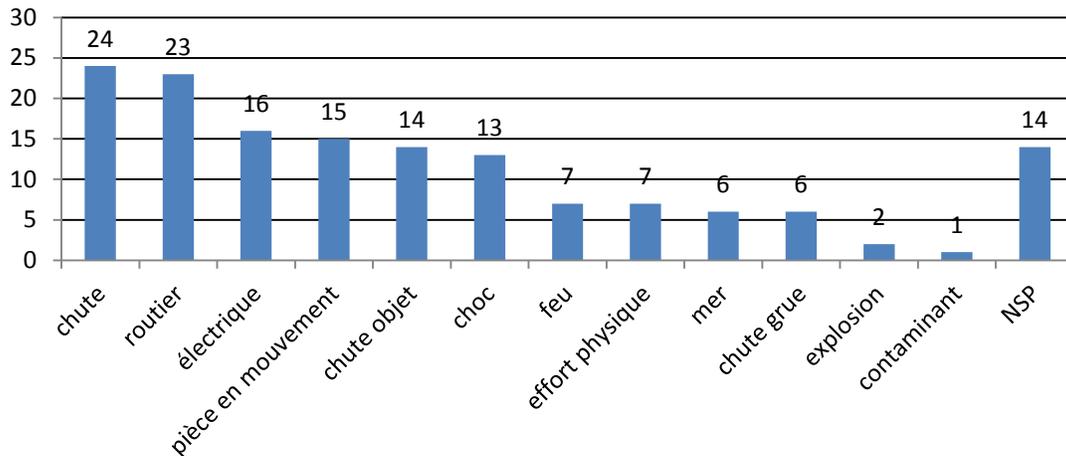
Figures 1 and 2 give the breakdown of the number of accidents and number of workers involved by accident cause. They show there were almost as many traffic accidents (23) as worker falls (24). The other causes, in order of importance, were electric shock (16), moving part (15), falling object (14), impact (13), fire (7), physical exertion (7), sea (6), crane collapse (6), explosion (2) and contaminant (1).

**Figure 1 – Accidents, by cause**

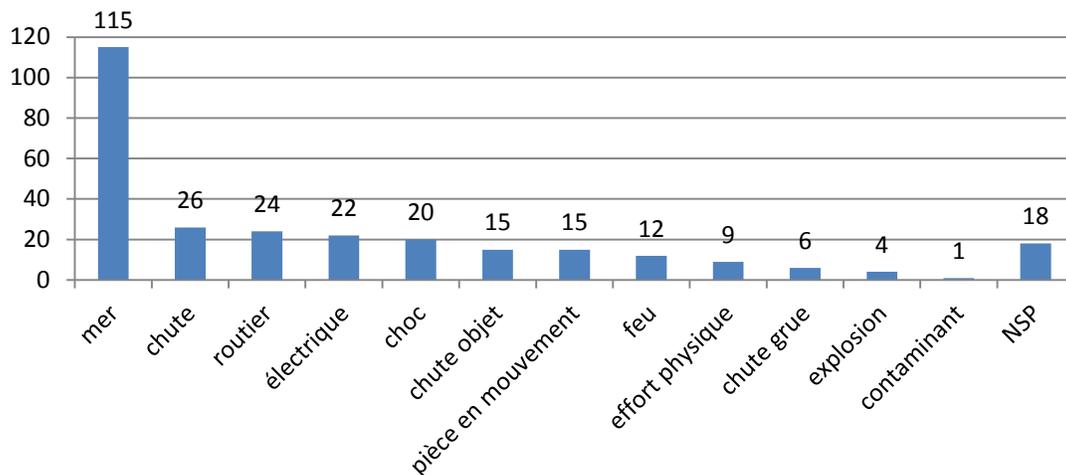
Note that the cause “sea” stands out immediately in terms of number of workers involved (Figure 2), as 113 workers were associated with four accidents having this cause: two transport accidents affected 33 workers, while two miscellaneous accidents involved 80 others.

**Figure 2 – Workers involved, by cause**

Except for the special case of the sea, the order of importance of the causes changes only slightly when the number of workers involved is considered rather than the number of accidents. Thus, more workers were involved in falls (26) than in traffic accidents (24). The other causes, in terms

of the number of workers involved, were electric shock (22), impact (20), falling object and moving part (15), fire (12), physical exertion (9), crane collapse (6), explosion (4) and contaminant (1).

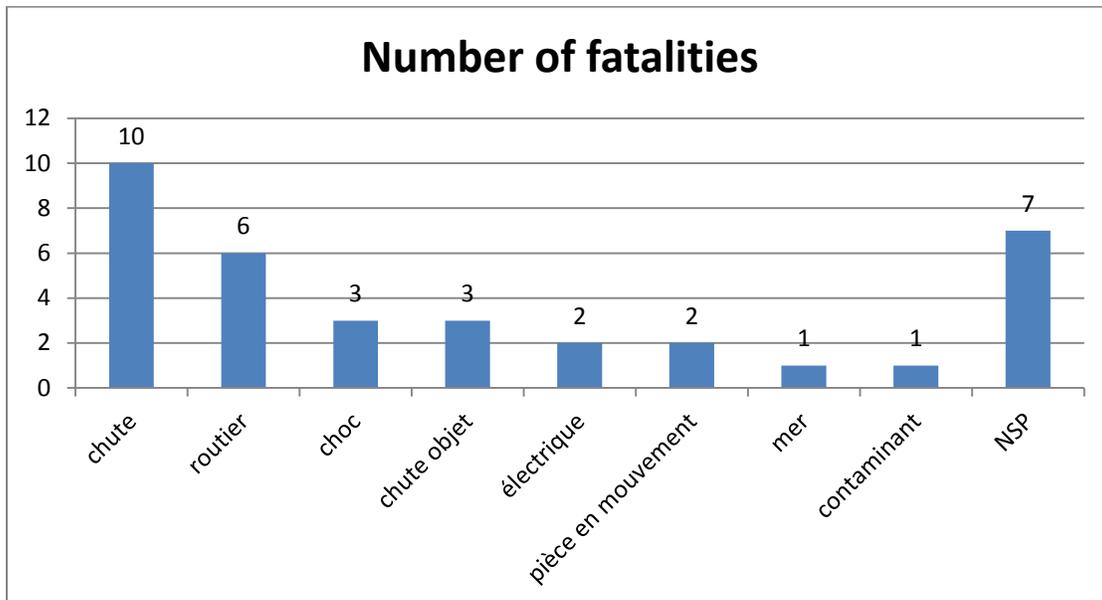
Figure 3 shows the number of worker fatalities by cause, while Figure 4 gives the number of workers injured by cause. The prime cause of fatalities (35) was falling (10) and the second biggest was traffic accidents (6). The number of fatalities classified as accidents with unspecified causes was high (7).

**Figure 3 – Fatalities, by cause**

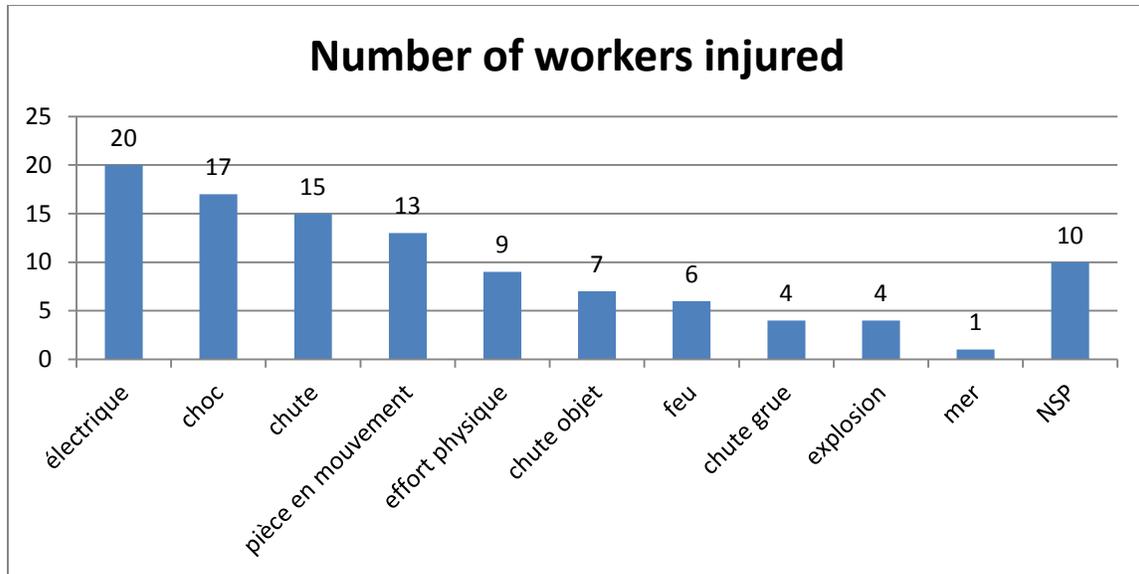
The breakdown of injured workers (106) by cause (Figure 4) differs sharply from the preceding classification. The two causes involving the greatest number of workers were electric shock (20) and impact (17), followed by falling (15). The other causes of injury, by order of importance, were moving part (13), physical exertion (9), falling object (7), fire (6), crane collapse (4), explosion (4) and sea (1).

**Figure 4 – Workers injured, by cause**

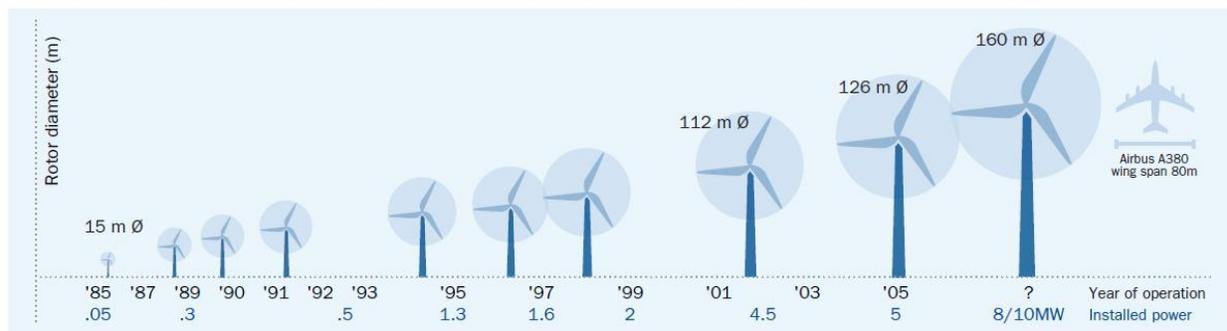
### Size evolution of wind turbines over time

**Figure 5 – Changes in wind turbine size and power**

The wind turbines currently in commercial use are three-blade machines spinning on a horizontal axis located in a nacelle at the top of a mast. The nacelle itself moves on a vertical axis in relation to the mast, which is fixed, so it can swing to face the wind. The nacelle contains the turbine's main components. However, changes in turbine power have led to changes in nacelle design and thus in safety conditions (see Figure 5):

- On turbines of 1.5 to 2.5 MW, especially the older ones, the nacelle is large enough for maintenance personnel to enter and perform their tasks while protected from the weather. To gain access to the hub connecting the three blades, workers usually have to go out through the top of the nacelle and then enter the hub. For most tasks, workers are therefore not exposed to the weather or the risk of falling.
- For the most recent 2 MW turbine models, the nacelle is designed to allow maintenance personnel to enter and perform their tasks protected from the weather. Access to the hub is directly through the nacelle without having to go outside. Maintenance personnel are therefore not exposed to the weather or to the risk of falling, except if they must perform work on the nacelle roof.

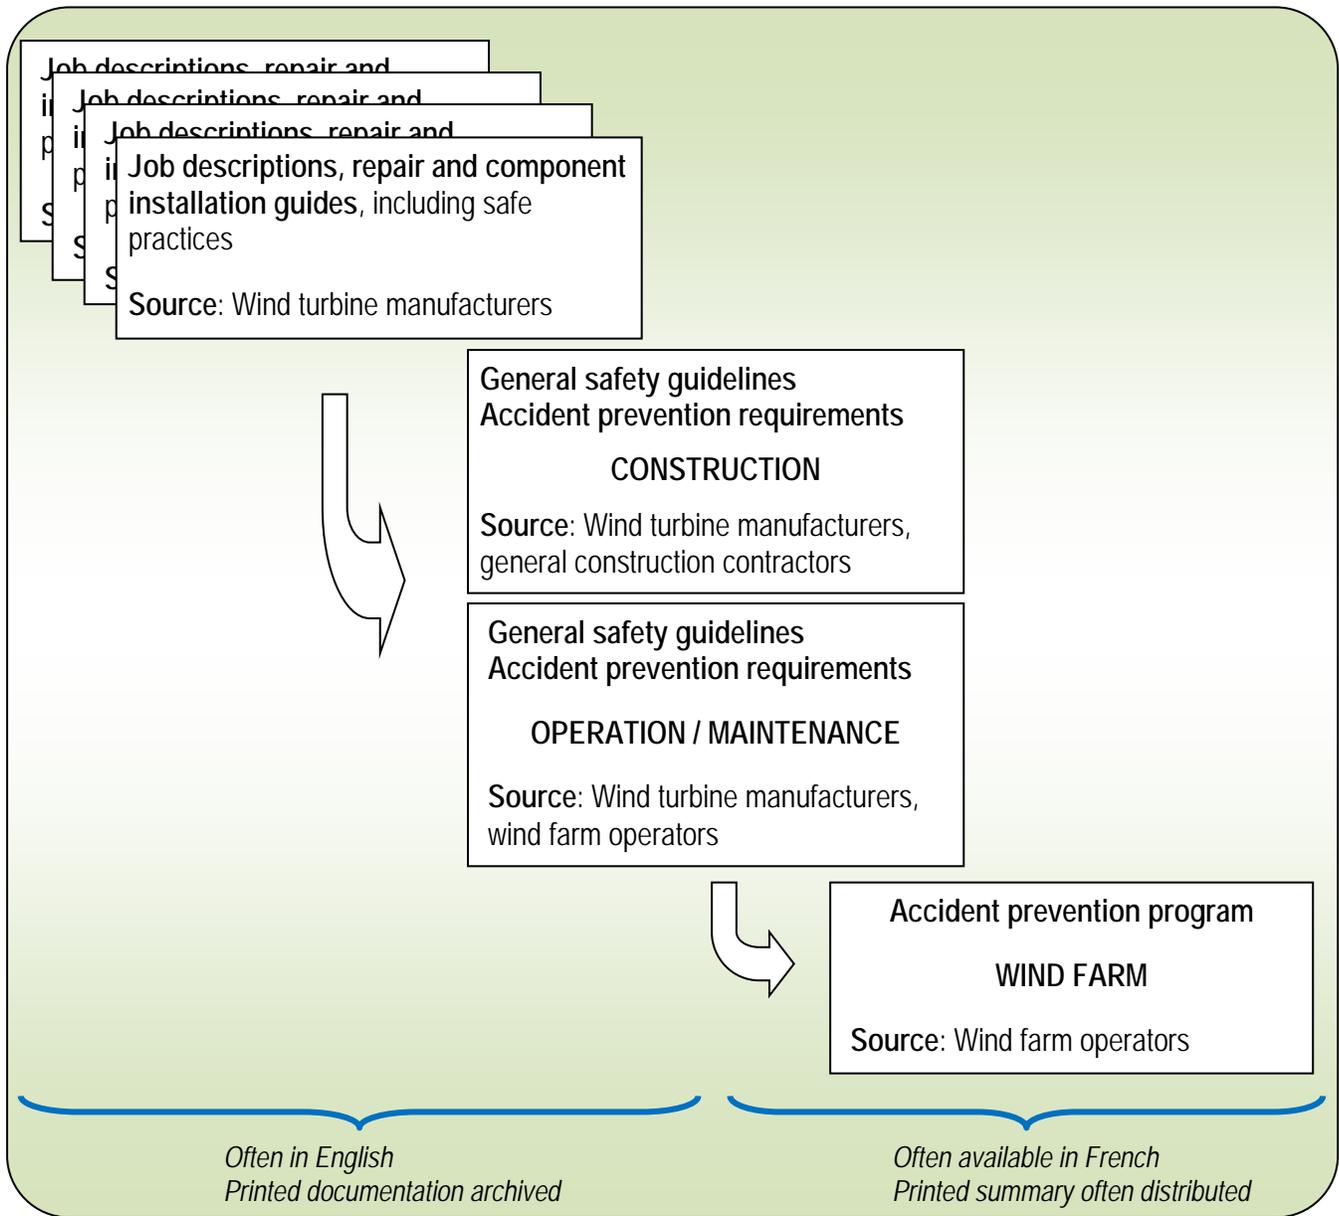
**Figure 6 – Documents and plans required for an accident prevention program**

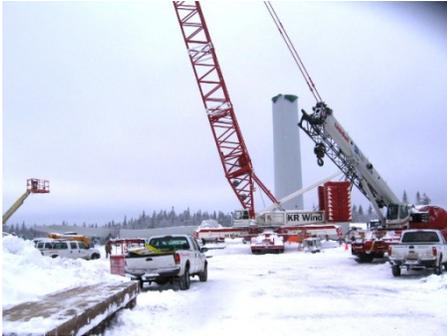
Construction site of two 2.5 MW REpower wind turbines for TCE, Rivière-au-Renard, Gaspé<sup>21</sup>
